Access Compliance Report

Public Rights-of-Way

(Curb Ramps)

| Intersection ID: 16830 | Main Street: MALVERN_RD | Cross Street: SHARON_RD | Location: SE |

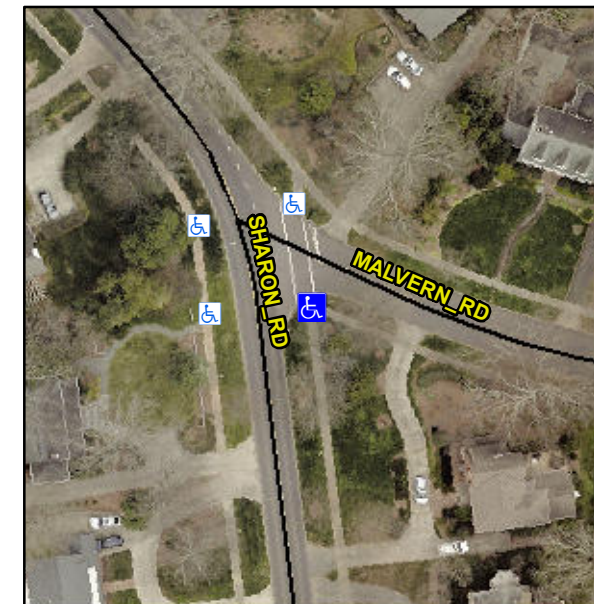
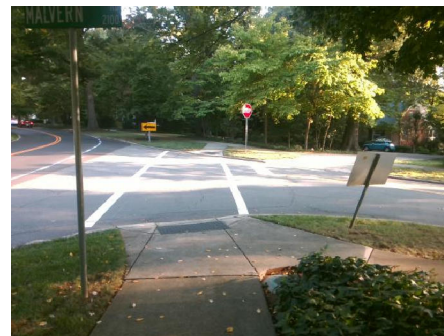
| ADA ID: 902D7A82919E | Ramp Type: PerpDiag | Initial Pass/Fail: Fail | Overall Compliance: No |

| Compliance | Description | Data | Compliance | Description | Data |
|---|---|---|---|---|---|
| N/A | Ramp Length (in) | 110.0 | No | Ramp Slope (%) | 12.2 |
| No | Ramp Width (in) | 45.0 | No | Ramp XSlope (%) | 3.1 |

Remove & Replace Curb Ramp With Two New Directional Ramps or Equivalent.
