Access Compliance Report

Public Rights-of-Way

(Curb Ramps)

Intersection ID: 9661	Main Street: CAMROSE_DR	Cross Street: THE_PLAZA	Location: SW
ADA ID: 902DA4CC91C6	Ramp Type: Perp	Initial Pass/Fail: Fail	Overall Compliance: No
Severity Score: 21.25			
Codes/Mitigation Info/Possible Solution		Field Measurements/Component Compliance

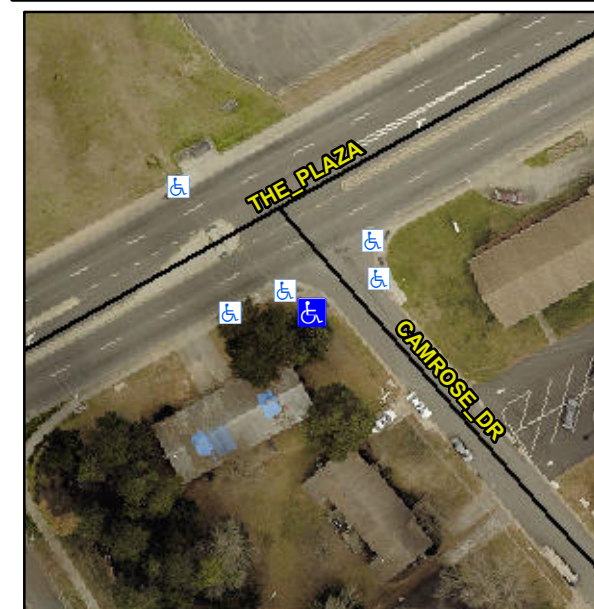
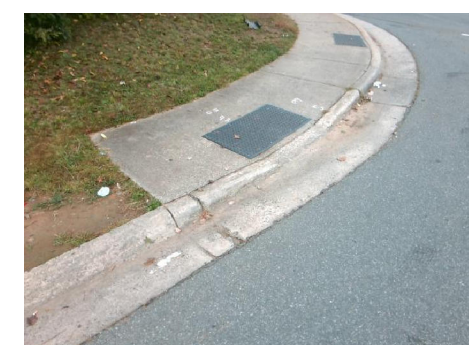
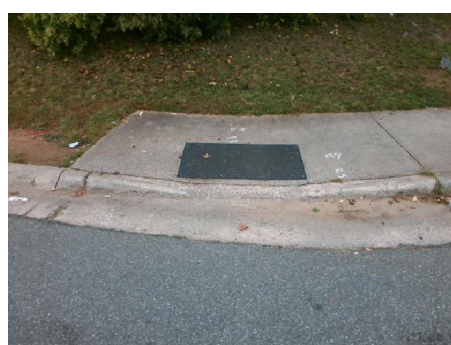
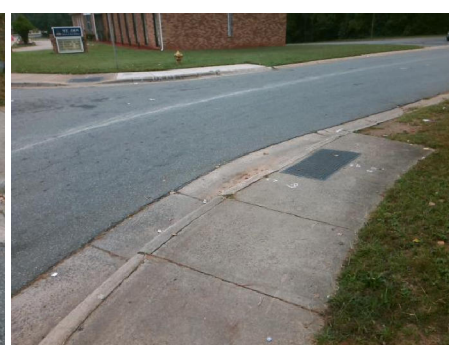
Not Found, R304.5.1, R304.2.2

Compliance	Description	Data	Compliance	Description	Data
N/A	Ramp Length (in)	58.0	No	Ramp Slope (%)	9.3
No	Ramp Width (in)	38.5	Yes	Ramp XSlope (%)	0.5
N/A	Flare Type LT	N/A	N/A	Flare Type RT	N/A
N/A	Flare Slope LT (%)	N/A	N/A	Flare Slope RT (%)	N/A
N/A	Flare Traversable LT?	N/A	N/A	Flare Traversable RT?	N/A
N/A	Landing Length (in)	N/A	N/A	DWS Provided?	N/A
N/A	Landing Width (in)	N/A	N/A	DWS Contrast?	N/A
N/A	Landing Slope (%)	N/A	N/A	DWS Length (in)	N/A
N/A	Landing X Slope (%)	N/A	N/A	DWS Full Width?	N/A
N/A	Landing Curb? (Y/N)	N/A	N/A	DWS Offset (in)	N/A
N/A	Shared Landing?	N/A			
N/A	Gutter Ponding?	N/A	N/A	Gutter Slope (%)	N/A
N/A	Gutter Lip Ht (in)	0.5	N/A	Gutter X Slope (%)	N/A
N/A	Painted X Walk1?	No	N/A	Painted X Walk2?	N/A
	X Walk 1 Direction	To NE		X Walk 2 Direction	N/A
N/A	X Walk 1 Width (in)	N/A	N/A	X Walk 2 Width (in)	N/A
	X Walk 1 Slope (%)	2.5		X Walk 2 Slope (%)	N/A
	X Walk 1 X Slope (%)	0.9		X Walk 2 X Slope (%)	N/A

N/A	Ramp inside XWalk1?	N/A	N/A	Ramp inside XWalk2?	N/A
	Road Slope (%)	N/A	N/A	Clear Space?	N/A
	Road X Slope (%)	N/A	N/A	Clear Space to XWalk (in)	N/A
N/A	Any Obstructions?	N/A	N/A	Storm Grate/Utility Hazard?	N/A
	Obstruction Type			Storm Grate/Utility Type	
		N/A			N/A
			Yes	Surface Condition? (G/P)	Good

Possible Solutions:

Remove & Replace Entire Ramp.
