# Access Compliance Report

## Public Rights-of-Way

### (Curb Ramps)

Intersection ID: 53776	Main Street: ELEANOR_RIGBY_RD	Cross Street: CHAPECLANE_RD	Location: SE
ADA ID: 9037DCD8A519	Ramp Type: BlendTrans1	Initial Pass/Fail: Fail	Overall Compliance: No
		Severity Score: 1.25

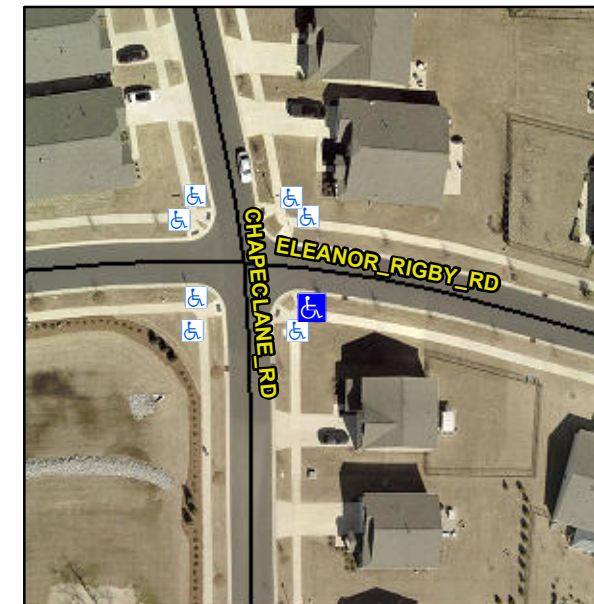
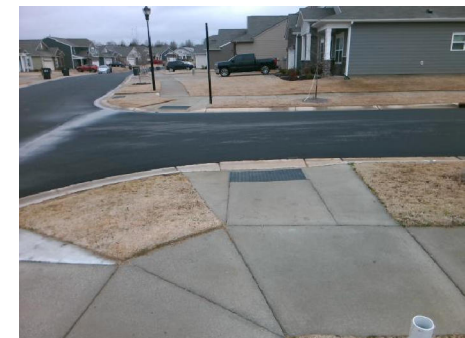
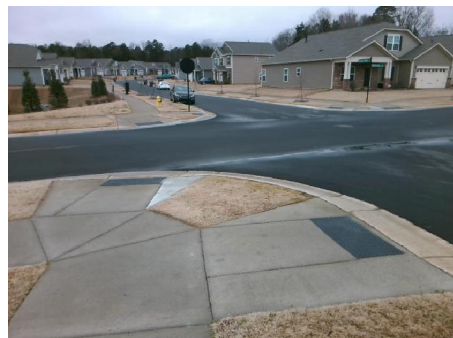
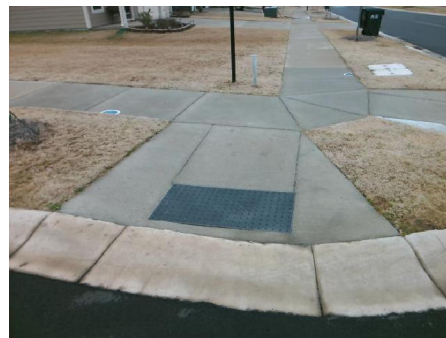
**Not Found, R304.5.3**

Compliance	Description	Data	Compliance	Description	Data
N/A	Ramp Length (in)	92.0	Yes	BlendTrans Slope (%)	1.4
Yes	Ramp Width (in)	48.0	No	BlendTrans XSlope (%)	2.6
N/A	Flare Type LT	N/A	N/A	Flare Type RT	N/A
N/A	Flare Slope LT (%)	N/A	N/A	Flare Slope RT (%)	N/A
N/A	Flare Traversable LT?	N/A	N/A	Flare Traversable RT?	N/A
N/A	Landing Length (in)	N/A	N/A	DWS Provided?	N/A
N/A	Landing Width (in)	N/A	N/A	DWS Contrast?	N/A
N/A	Landing Slope (%)	N/A	N/A	DWS Length (in)	N/A
N/A	Landing X Slope (%)	N/A	N/A	DWS Full Width?	N/A
N/A	Landing Curb? (Y/N)	N/A	N/A	DWS Offset (in)	N/A
N/A	Shared Landing?	N/A			
N/A	Gutter Ponding?	N/A	N/A	Gutter Slope (%)	N/A
N/A	Gutter Lip Ht (in)	N/A	N/A	Gutter X Slope (%)	N/A
N/A	Painted X Walk1?	No	N/A	Painted X Walk2?	N/A
	X Walk 1 Direction	To N		X Walk 2 Direction	N/A
	X Walk 1 Width (in)	N/A		X Walk 2 Width (in)	N/A
	X Walk 1 Slope (%)	0.9		X Walk 2 Slope (%)	N/A
	X Walk 1 X Slope (%)	2.6		X Walk 2 X Slope (%)	N/A

N/A	Ramp inside XWalk1?	N/A	N/A	Ramp inside XWalk2?	N/A
	Road Slope (%)	2.6		Clear Space?	N/A
	Road X Slope (%)	0.9	N/A	Clear Space to XWalk (in)	N/A
N/A	Any Obstructions?	N/A	N/A	Storm Grate/Utility Hazard?	N/A
	Obstruction Type			Storm Grate/Utility Type	
		N/A			N/A
			Yes	Surface Condition? (G/P)	Good
			No	Curb Slope (%)	6.0

**Remove & Replace Curb Ramp With Two New Directional Ramps or Equivalent.**
