Access Compliance Report

Public Rights-of-Way

(Curb Ramps)

Intersection ID: 10028931	Main Street: IDLEWILD_RD	Cross Street: N/A	Location:	N
ADA ID: 9039DBB5E74C	Ramp Type: PerpDiag	Initial Pass/Fail: Fail	Overall Compliance: No	Severity Score: 22.5

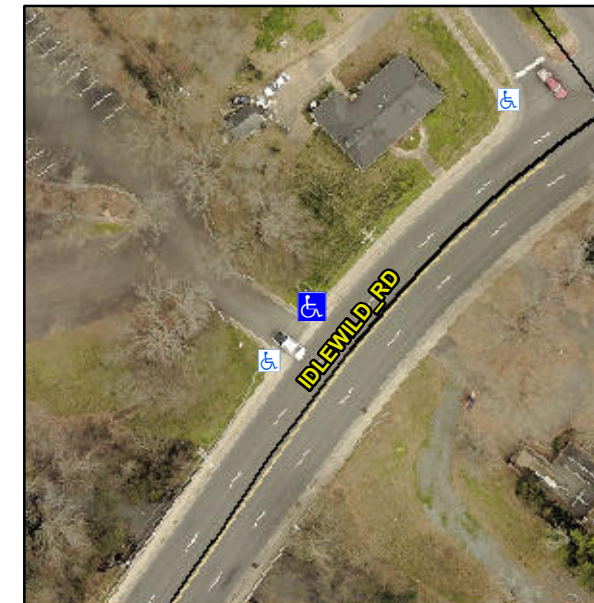
Not Found, R304.5.1, R304.2.2

Compliance	Description	Data	Compliance	Description	Data
N/A	Ramp Length (in)	60.0	No	Ramp Slope (%)	8.7
No	Ramp Width (in)	38.0	Yes	Ramp XSlope (%)	4.8
N/A	Flare Type LT	N/A	N/A	Flare Type RT	N/A
N/A	Flare Slope LT (%)	N/A	N/A	Flare Slope RT (%)	N/A
N/A	Flare Traversable LT?	N/A	N/A	Flare Traversable RT?	N/A
N/A	Landing Length (in)	N/A	N/A	DWS Provided?	N/A
N/A	Landing Width (in)	N/A	N/A	DWS Contrast?	N/A
N/A	Landing Slope (%)	N/A	N/A	DWS Length (in)	N/A
N/A	Landing X Slope (%)	N/A	N/A	DWS Full Width?	N/A
N/A	Landing Curb? (Y/N)	N/A	N/A	DWS Offset (in)	N/A
N/A	Shared Landing?	N/A			
N/A	Gutter Ponding?	N/A	N/A	Gutter Slope (%)	N/A
N/A	Gutter Lip Ht (in)	N/A	N/A	Gutter X Slope (%)	N/A
N/A	Painted X Walk1?	No	N/A	Painted X Walk2?	No
	X Walk 1 Direction	To SW		X Walk 2 Direction	To SE
N/A	X Walk 1 Width (in)	N/A	N/A	X Walk 2 Width (in)	N/A
	X Walk 1 Slope (%)	1.9		X Walk 2 Slope (%)	4.5
	X Walk 1 X Slope (%)	4.8		X Walk 2 X Slope (%)	1.5

N/A	Ramp inside XWalk1?	N/A	N/A	Ramp inside XWalk2?	N/A
	Road Slope (%)	6.0	N/A	Clear Space?	N/A
	Road X Slope (%)	0.4	N/A	Clear Space to XWalk (in)	N/A
N/A	Any Obstructions?	N/A	N/A	Storm Grate/Utility Hazard?	N/A
	Obstruction Type			Storm Grate/Utility Type	
		N/A			N/A
			Yes	Surface Condition? (G/P)	Good

Remove & Replace Curb Ramp With Two New Directional Ramps or Equivalent.
