Access Compliance Report

Public Rights-of-Way

(Curb Ramps)

Intersection ID: 27786	Main Street: BISHAR_LN	Cross Street: BRICK_CHURCH_CT	Location: W
ADA ID: 903D0778D23F	Ramp Type: PerpDiag	Initial Pass/Fail: Fail	Overall Compliance: No
Severity Score: 17.5			
Codes/Mitigation Info/Possible Solution		Field Measurements/Component Compliance

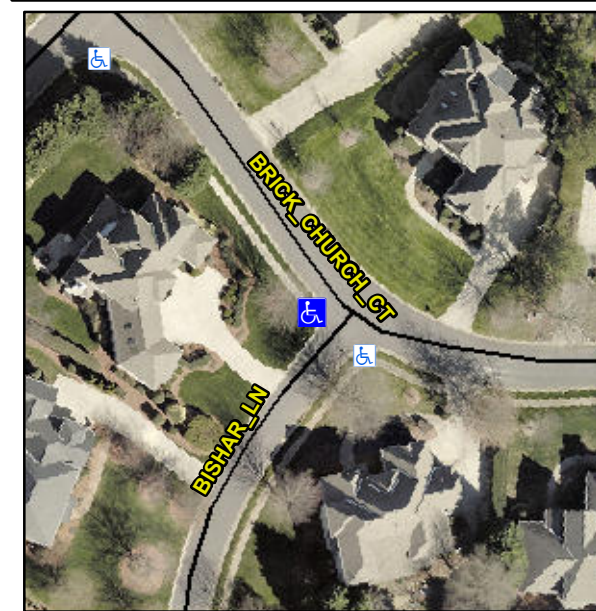
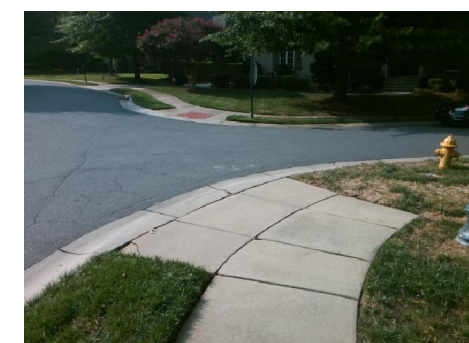
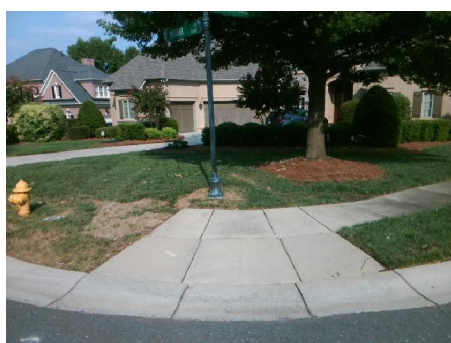
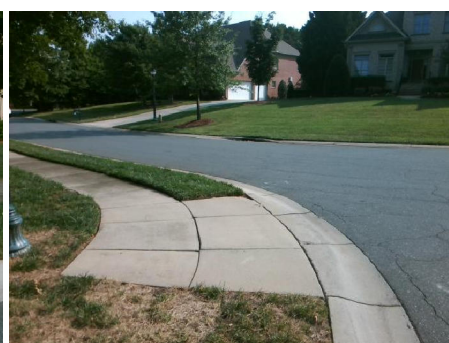
Not Found, R304.5.1

Compliance	Description	Data	Compliance	Description	Data
N/A	Ramp Length (in)	96.0	Yes	Ramp Slope (%)	5.4
No	Ramp Width (in)	34.0	Yes	Ramp XSlope (%)	0.1
N/A	Flare Type LT	N/A	N/A	Flare Type RT	N/A
N/A	Flare Slope LT (%)	N/A	N/A	Flare Slope RT (%)	N/A
N/A	Flare Traversable LT?	N/A	N/A	Flare Traversable RT?	N/A
N/A	Landing Length (in)	N/A	N/A	DWS Provided?	N/A
N/A	Landing Width (in)	N/A	N/A	DWS Contrast?	N/A
N/A	Landing Slope (%)	N/A	N/A	DWS Length (in)	N/A
N/A	Landing X Slope (%)	N/A	N/A	DWS Full Width?	N/A
N/A	Landing Curb? (Y/N)	N/A	N/A	DWS Offset (in)	N/A
N/A	Shared Landing?	N/A			
N/A	Gutter Ponding?	N/A	N/A	Gutter Slope (%)	N/A
N/A	Gutter Lip Ht (in)	N/A	N/A	Gutter X Slope (%)	N/A
N/A	Painted X Walk1?	No	N/A	Painted X Walk2?	No
	X Walk 1 Direction	To SE		X Walk 2 Direction	To NE
N/A	X Walk 1 Width (in)	N/A	N/A	X Walk 2 Width (in)	N/A
	X Walk 1 Slope (%)	2.9		X Walk 2 Slope (%)	1.0
	X Walk 1 X Slope (%)	1.0		X Walk 2 X Slope (%)	3.3

N/A	Ramp inside XWalk1?	N/A	N/A	Ramp inside XWalk2?	N/A
	Road Slope (%)	1.1	N/A	Clear Space?	N/A
	Road X Slope (%)	2.9	N/A	Clear Space to XWalk (in)	N/A
N/A	Any Obstructions?	N/A	N/A	Storm Grate/Utility Hazard?	N/A
	Obstruction Type			Storm Grate/Utility Type	
		N/A			N/A
			Yes	Surface Condition? (G/P)	Good

Remove & Replace Curb Ramp With Two New Directional Ramps or Equivalent.

Total Cost: \$ 3200.00
