Access Compliance Report

Public Rights-of-Way

(Curb Ramps)

| Intersection ID: 15235 | Main Street: IDEAL_WY | Cross Street: IVERSON_WY | Location: SE |

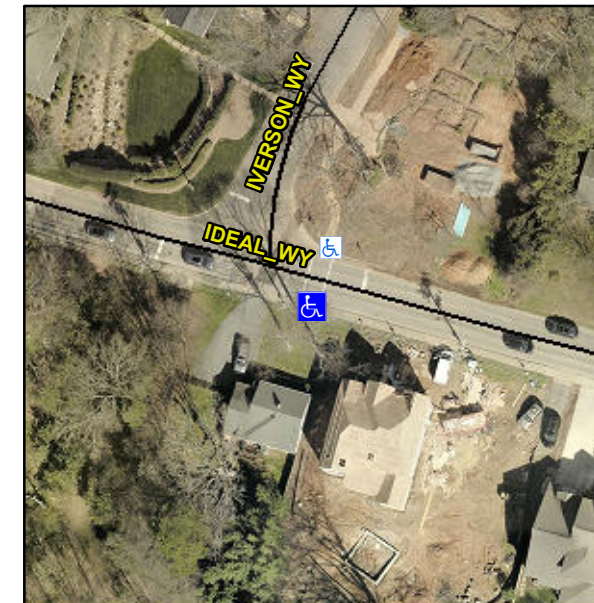
NO CURB LINE

Not Found, R304.5.1, R304.5.3, R304.3.2

| Compliance | Description | Data | Compliance | Description | Data |
|---|---|---|---|---|---|
| No | Ramp Width LT (in) | 33.0 | N/A | Ramp Width RT (in) | N/A |
| No | Ramp Slope LT (%) | 8.7 | N/A | Ramp Slope RT (%) | N/A |
| No | Ramp XSlope LT (%) | 3.3 | N/A | Ramp XSlope RT (%) | N/A |
| Yes | Ramp Width (in) | 48.0 | No | Ramp XSlope (%) | 5.6 |

Remove & Replace Entire Ramp.
