# Access Compliance Report

## Public Rights-of-Way

### (Curb Ramps)

Intersection ID: N/A	Main Street: SPEER_BV	Cross Street: NATIONAL_AV	Location: E
ADA ID: 9044F5FDCB0E	Ramp Type: Perp	Initial Pass/Fail: Fail	Overall Compliance: No
Codes/Mitigation Info/Possible Solution		Field Measurements/Component Compliance	
Severity Score: 22.5

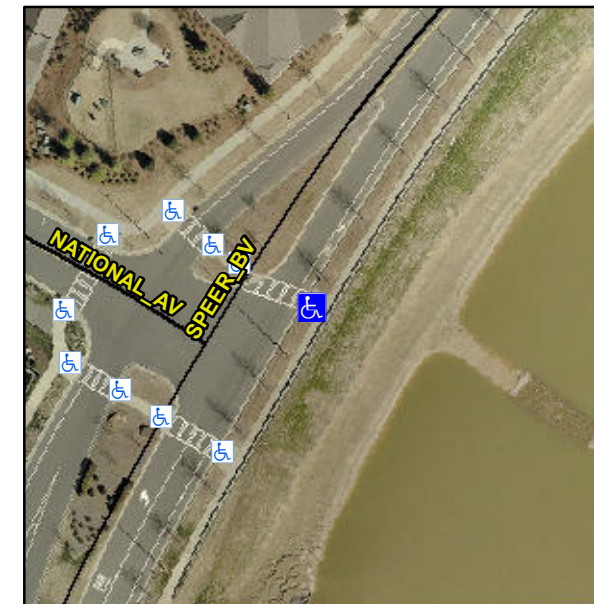
**Not Found, R304.5.1, R304.2.2, R304.5.3**

Compliance	Description	Data	Compliance	Description	Data
N/A	Ramp Length (in)	94.0	No	Ramp Slope (%)	9.5
No	Ramp Width (in)	46.5	No	Ramp XSlope (%)	2.1
N/A	Flare Type LT	N/A	N/A	Flare Type RT	N/A
N/A	Flare Slope LT (%)	N/A	N/A	Flare Slope RT (%)	N/A
N/A	Flare Traversable LT?	N/A	N/A	Flare Traversable RT?	N/A
N/A	Landing Length (in)	N/A	N/A	DWS Provided?	N/A
N/A	Landing Width (in)	N/A	N/A	DWS Contrast?	N/A
N/A	Landing Slope (%)	N/A	N/A	DWS Length (in)	N/A
N/A	Landing X Slope (%)	N/A	N/A	DWS Full Width?	N/A
N/A	Landing Curb? (Y/N)	N/A	N/A	DWS Offset (in)	N/A
N/A	Shared Landing?	N/A			
N/A	Gutter Ponding?	N/A	N/A	Gutter Slope (%)	N/A
N/A	Gutter Lip Ht (in)	N/A	N/A	Gutter X Slope (%)	N/A
N/A	Painted X Walk1?	Yes	N/A	Painted X Walk2?	N/A
	X Walk 1 Direction	To NW		X Walk 2 Direction	N/A
N/A	X Walk 1 Width (in)	112.0	N/A	X Walk 2 Width (in)	N/A
	X Walk 1 Slope (%)	2.2		X Walk 2 Slope (%)	N/A
	X Walk 1 X Slope (%)	1.2		X Walk 2 X Slope (%)	N/A

N/A	Ramp inside XWalk1?	Yes	N/A	Ramp inside XWalk2?	N/A
	Road Slope (%)	N/A	N/A	Clear Space?	N/A
	Road X Slope (%)	N/A	N/A	Clear Space to XWalk (in)	N/A
N/A	Any Obstructions?	N/A	N/A	Storm Grate/Utility Hazard?	N/A
	Obstruction Type			Storm Grate/Utility Type	
		N/A			N/A
			Yes	Surface Condition? (G/P)	Good

**Remove & Replace Entire Ramp.**

Total Cost: \$ 1850.00
