Access Compliance Report

Public Rights-of-Way

(Curb Ramps)

Intersection ID: 3740	Main Street: CHESTNUT_KNOLL_LN	Cross Street: DAVIS_LAKE_PY	Location:	W
ADA ID: 9049717EC057	Ramp Type: Perp	Initial Pass/Fail: Fail	Overall Compliance: No	Severity Score: 10
Codes/Mitigation Info/Possible Solution		Field Measurements/Component Compliance

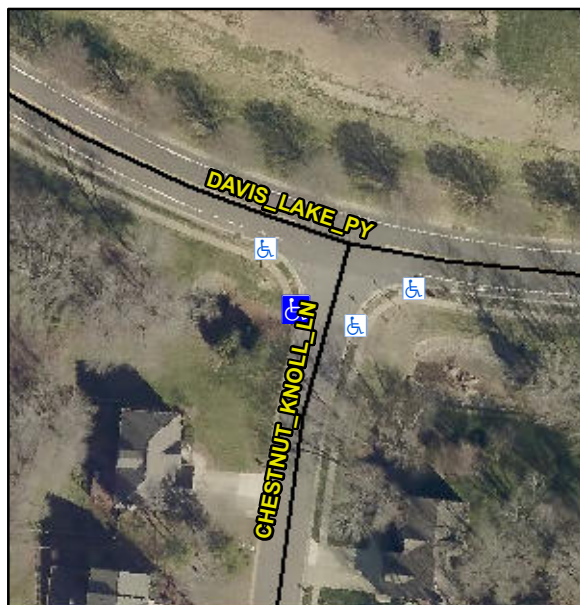
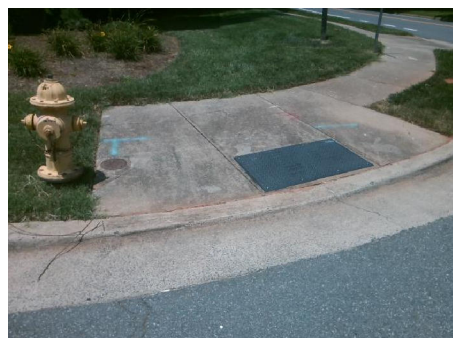
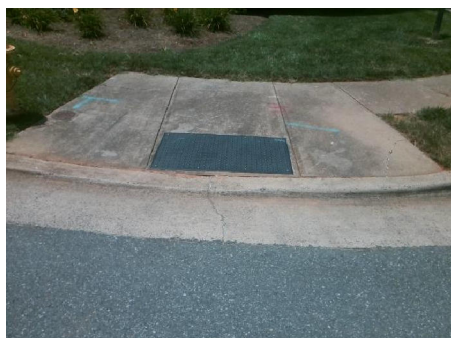
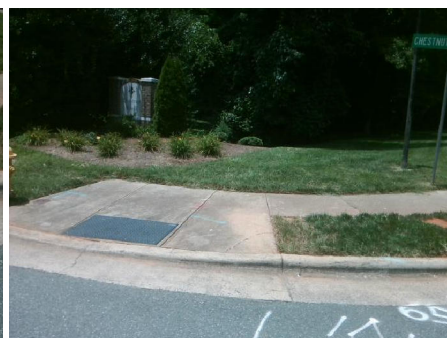
Not Found, R304.5.1, R304.5.3

Compliance	Description	Data	Compliance	Description	Data
N/A	Ramp Length (in)	53.0	Yes	Ramp Slope (%)	7.6
No	Ramp Width (in)	46.0	No	Ramp XSlope (%)	4.6
N/A	Flare Type LT	N/A	N/A	Flare Type RT	N/A
N/A	Flare Slope LT (%)	N/A	N/A	Flare Slope RT (%)	N/A
N/A	Flare Traversable LT?	N/A	N/A	Flare Traversable RT?	N/A
N/A	Landing Length (in)	N/A	N/A	DWS Provided?	N/A
N/A	Landing Width (in)	N/A	N/A	DWS Contrast?	N/A
N/A	Landing Slope (%)	N/A	N/A	DWS Length (in)	N/A
N/A	Landing X Slope (%)	N/A	N/A	DWS Full Width?	N/A
N/A	Landing Curb? (Y/N)	N/A	N/A	DWS Offset (in)	N/A
N/A	Shared Landing?	N/A			
N/A	Gutter Ponding?	N/A	N/A	Gutter Slope (%)	N/A
N/A	Gutter Lip Ht (in)	N/A	N/A	Gutter X Slope (%)	N/A
N/A	Painted X Walk1?	No	N/A	Painted X Walk2?	N/A
	X Walk 1 Direction	To SE		X Walk 2 Direction	N/A
N/A	X Walk 1 Width (in)	N/A	N/A	X Walk 2 Width (in)	N/A
	X Walk 1 Slope (%)	3.2		X Walk 2 Slope (%)	N/A
	X Walk 1 X Slope (%)	1.4		X Walk 2 X Slope (%)	N/A

N/A	Ramp inside XWalk1?	N/A	N/A	Ramp inside XWalk2?	N/A
	Road Slope (%)	N/A	N/A	Clear Space?	N/A
	Road X Slope (%)	N/A	N/A	Clear Space to XWalk (in)	N/A
N/A	Any Obstructions?	N/A	N/A	Storm Grate/Utility Hazard?	N/A
	Obstruction Type			Storm Grate/Utility Type	
		N/A			N/A
			Yes	Surface Condition? (G/P)	Good

Remove & Replace Entire Ramp.
