# Access Compliance Report

## Public Rights-of-Way

### (Curb Ramps)

| Intersection ID: 14201 | Main Street: RANLO_AV | Cross Street: BALDWIN_AV | Location: W |

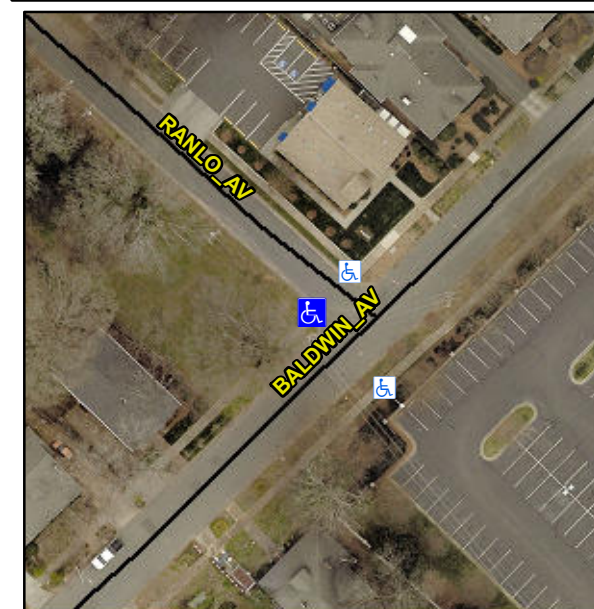
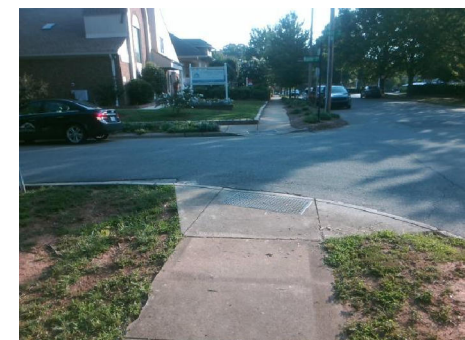
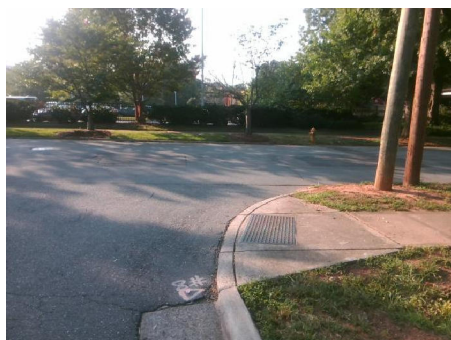
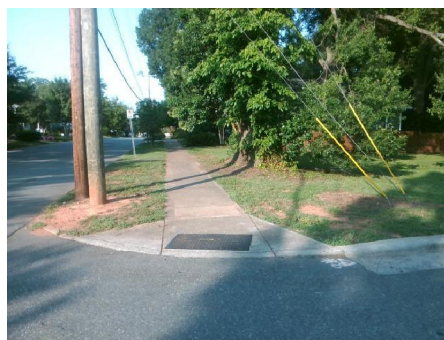
| ADA ID: 904A1BD3EAEF | Ramp Type: BlendTrans1 | Initial Pass/Fail: Pass | Overall Compliance: No |
| | | Severity Score: 2.75 | |

| Compliance | Description | Data | Compliance | Description | Data |
|---|---|---|---|---|---|
| Yes | Ramp Width (in) | 57.0 | No | BlendTrans XSlope (%) | 3.3 |
| Yes | Landing X Slope (%) | 1.3 | No | DWS Full Width? | No |
| N/A | Landing Curb? (Y/N) | No | No | DWS Offset (in) | 3.0 |
| Yes | Gutter Lip Ht (in) | 0.0 | No | Gutter X Slope (%) | 3.6 |

**Remove & Replace Curb Ramp With Two New Directional Ramps or Equivalent. Remove & Replace Gutter.**

**R304.5.3, R305.1.4, R305.2**

Total Cost: \$ 3950.00
