# Access Compliance Report

## Public Rights-of-Way

### (Curb Ramps)

Intersection ID: 44298	Main Street: PEACH_PLACE_LN	Cross Street: CRANDON_DR	Location: SE
ADA ID: 9051E09AB1A0	Ramp Type: PerpDiag	Initial Pass/Fail: Fail	Overall Compliance: No
Severity Score: 25			
Codes/Mitigation Info/Possible Solution		Field Measurements/Component Compliance

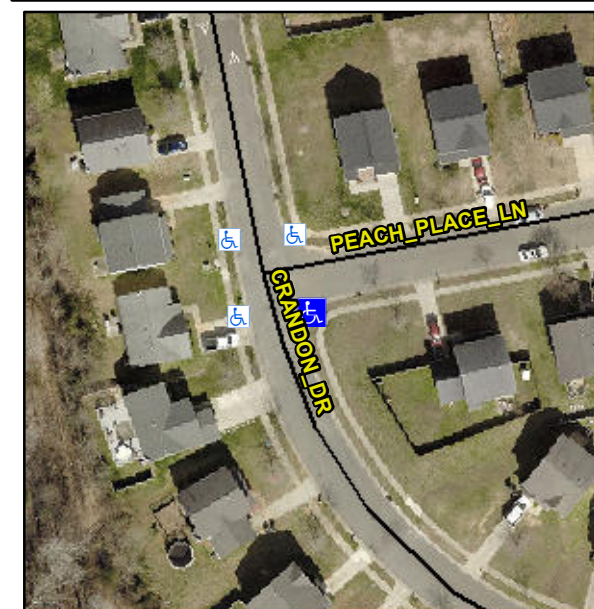
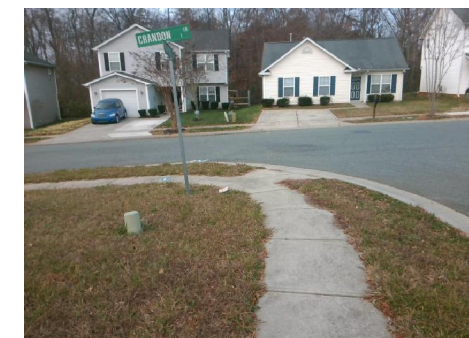
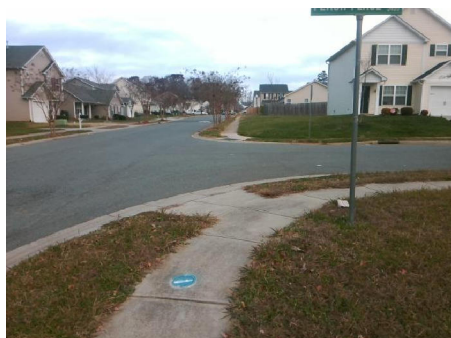
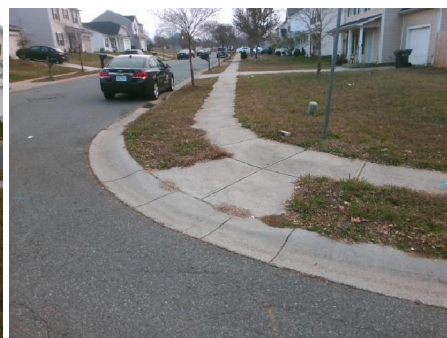
**Not Found, R304.5.3**

Compliance	Description	Data	Compliance	Description	Data
N/A	Ramp Length (in)	46.5	Yes	Ramp Slope (%)	7.3
Yes	Ramp Width (in)	70.0	No	Ramp XSlope (%)	7.8
N/A	Flare Type LT	N/A	N/A	Flare Type RT	N/A
N/A	Flare Slope LT (%)	N/A	N/A	Flare Slope RT (%)	N/A
N/A	Flare Traversable LT?	N/A	N/A	Flare Traversable RT?	N/A
N/A	Landing Length (in)	N/A	N/A	DWS Provided?	N/A
N/A	Landing Width (in)	N/A	N/A	DWS Contrast?	N/A
N/A	Landing Slope (%)	N/A	N/A	DWS Length (in)	N/A
N/A	Landing X Slope (%)	N/A	N/A	DWS Full Width?	N/A
N/A	Landing Curb? (Y/N)	N/A	N/A	DWS Offset (in)	N/A
N/A	Shared Landing?	N/A			
N/A	Gutter Ponding?	N/A	N/A	Gutter Slope (%)	N/A
N/A	Gutter Lip Ht (in)	N/A	N/A	Gutter X Slope (%)	N/A
N/A	Painted X Walk1?	No	N/A	Painted X Walk2?	No
	X Walk 1 Direction	To N		X Walk 2 Direction	To W
N/A	X Walk 1 Width (in)	N/A	N/A	X Walk 2 Width (in)	N/A
	X Walk 1 Slope (%)	4.4		X Walk 2 Slope (%)	3.4
	X Walk 1 X Slope (%)	1.9		X Walk 2 X Slope (%)	3.0

N/A	Ramp inside XWalk1?	N/A	N/A	Ramp inside XWalk2?	N/A
	Road Slope (%)	4.6	N/A	Clear Space?	N/A
	Road X Slope (%)	3.2	N/A	Clear Space to XWalk (in)	N/A
N/A	Any Obstructions?	N/A	N/A	Storm Grate/Utility Hazard?	N/A
	Obstruction Type			Storm Grate/Utility Type	
		N/A			N/A
		Yes		Surface Condition? (G/P)	Good

**Remove & Replace Curb Ramp With Two New Directional Ramps or Equivalent.**

Total Cost: \$ 3200.00
