Access Compliance Report

Public Rights-of-Way

(Curb Ramps)

Intersection ID: 10027835	Main Street: HAMILTON_CR	Cross Street: N/A	Location: S
ADA ID: 905388446BEE	Ramp Type: Perp	Initial Pass/Fail: Pass	Overall Compliance: No
Codes/Mitigation Info/Possible Solution		Field Measurements/Component Compliance

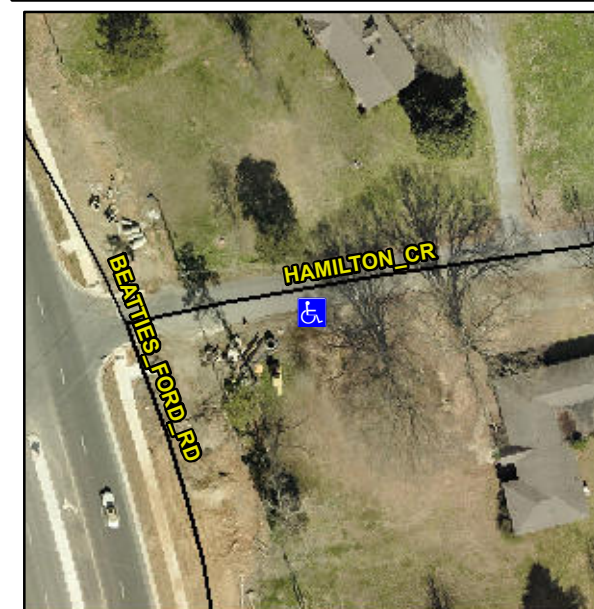
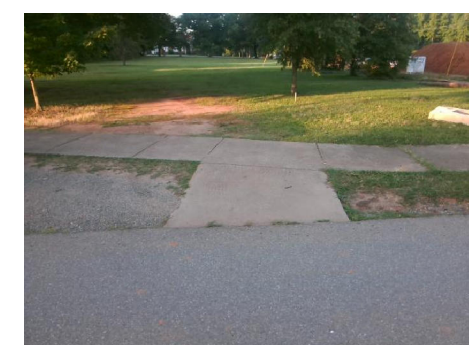
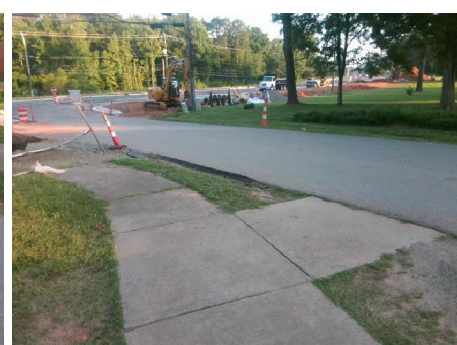
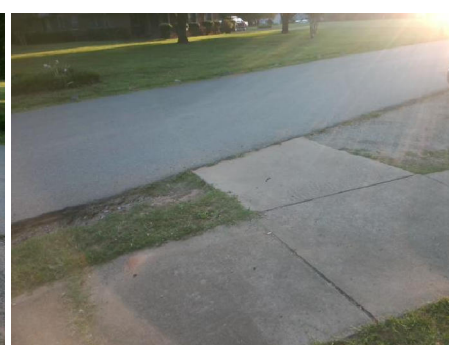
Compliance	Description	Data	Compliance	Description	Data
N/A	Ramp Length (in)	61.0	Yes	Ramp Slope (%)	5.8
Yes	Ramp Width (in)	77.5	No	Ramp XSlope (%)	4.9
N/A	Flare Type LT	None	N/A	Flare Type RT	N/A
N/A	Flare Slope LT (%)	N/A	N/A	Flare Slope RT (%)	N/A
N/A	Flare Traversable LT?	N/A	N/A	Flare Traversable RT?	N/A
Yes	Landing Length (in)	60.0	No	DWS Provided?	No
Yes	Landing Width (in)	70.5	N/A	DWS Contrast?	No
Yes	Landing Slope (%)	0.7	N/A	DWS Length (in)	N/A
Yes	Landing X Slope (%)	3.0	N/A	DWS Full Width?	No
N/A	Landing Curb? (Y/N)	No	N/A	DWS Offset (in)	N/A
N/A	Shared Landing?	No			
Yes	Gutter Ponding?	No	Yes	Gutter Slope (%)	4.6
No	Gutter Lip Ht (in)	0.5	No	Gutter X Slope (%)	3.5
N/A	Painted X Walk1?	No	N/A	Painted X Walk2?	N/A
	X Walk 1 Direction	To N		X Walk 2 Direction	N/A
N/A	X Walk 1 Width (in)	N/A	N/A	X Walk 2 Width (in)	N/A
	X Walk 1 Slope (%)	1.5		X Walk 2 Slope (%)	N/A
	X Walk 1 X Slope (%)	3.0		X Walk 2 X Slope (%)	N/A

N/A	Ramp inside XWalk1?	N/A	N/A	Ramp inside XWalk2?	N/A
	Road Slope (%)	N/A	N/A	Clear Space?	Yes
	Road X Slope (%)	N/A	N/A	Clear Space to XWalk (in)	N/A
Yes	Any Obstructions?	No	Yes	Storm Grate/Utility Hazard?	No
	Obstruction Type			Storm Grate/Utility Type	
		N/A			N/A
			Yes	Surface Condition? (G/P)	Good

Possible Solutions:

**Remove & Replace Entire Ramp.
Remove & Replace Gutter.**

R304.5.3, R305, R302.7.2
