Access Compliance Report

Public Rights-of-Way

(Curb Ramps)

Intersection ID: 17009	Main Street: N_WENDOVER_RD	Cross Street: RANDOLPH_RD	Location: N
ADA ID: 9054DB2DB2FA	Ramp Type: Perp	Initial Pass/Fail: Fail	Overall Compliance: No
			Severity Score: 18.75

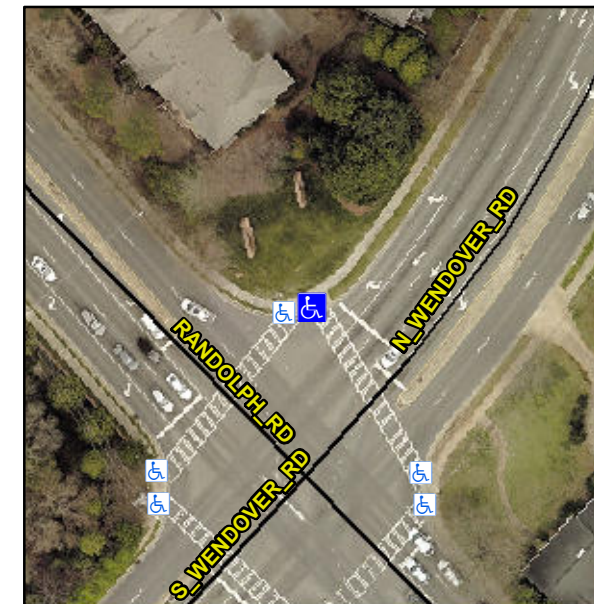
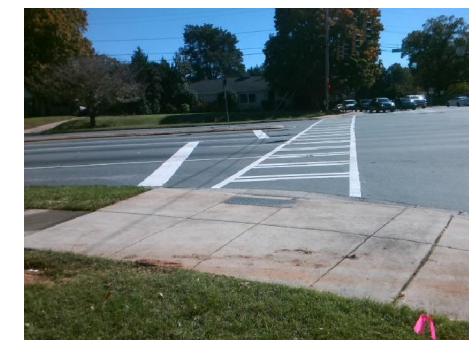
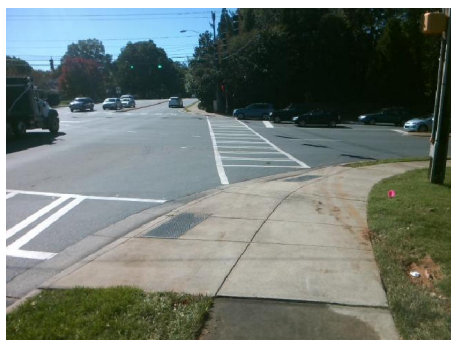
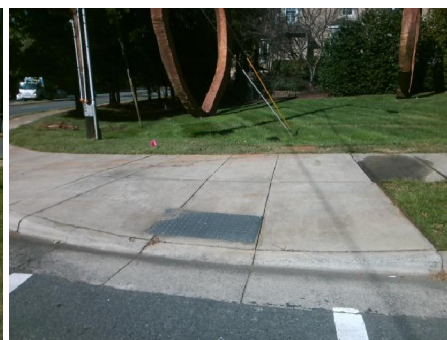
Not Found, R304.5.1, R304.5.3

Compliance	Description	Data	Compliance	Description	Data
N/A	Ramp Length (in)	131.0	Yes	Ramp Slope (%)	6.5
No	Ramp Width (in)	34.5	No	Ramp XSlope (%)	4.9
N/A	Flare Type LT	N/A	N/A	Flare Type RT	N/A
N/A	Flare Slope LT (%)	N/A	N/A	Flare Slope RT (%)	N/A
N/A	Flare Traversable LT?	N/A	N/A	Flare Traversable RT?	N/A
N/A	Landing Length (in)	N/A	N/A	DWS Provided?	N/A
N/A	Landing Width (in)	N/A	N/A	DWS Contrast?	N/A
N/A	Landing Slope (%)	N/A	N/A	DWS Length (in)	N/A
N/A	Landing X Slope (%)	N/A	N/A	DWS Full Width?	N/A
N/A	Landing Curb? (Y/N)	N/A	N/A	DWS Offset (in)	N/A
N/A	Shared Landing?	N/A			
N/A	Gutter Ponding?	N/A	N/A	Gutter Slope (%)	N/A
N/A	Gutter Lip Ht (in)	N/A	N/A	Gutter X Slope (%)	N/A
N/A	Painted X Walk1?	Yes	N/A	Painted X Walk2?	N/A
	X Walk 1 Direction	To SE		X Walk 2 Direction	N/A
N/A	X Walk 1 Width (in)	104.0	N/A	X Walk 2 Width (in)	N/A
	X Walk 1 Slope (%)	0.7		X Walk 2 Slope (%)	N/A
	X Walk 1 X Slope (%)	3.4		X Walk 2 X Slope (%)	N/A

N/A	Ramp inside XWalk1?	Yes	N/A	Ramp inside XWalk2?	N/A
	Road Slope (%)	N/A	N/A	Clear Space?	N/A
	Road X Slope (%)	N/A	N/A	Clear Space to XWalk (in)	N/A
N/A	Any Obstructions?	N/A	N/A	Storm Grate/Utility Hazard?	N/A
	Obstruction Type			Storm Grate/Utility Type	
		N/A			N/A
			Yes	Surface Condition? (G/P)	Good

Remove & Replace Entire Ramp.

Total Cost: \$ 1850.00
