# Access Compliance Report

## Public Rights-of-Way

### (Curb Ramps)

Intersection ID: 10033028	Main Street: NOBLES_AV	Cross Street: N/A	Location: NW
ADA ID: 90609CA8BDCD	Ramp Type: Perp	Initial Pass/Fail: Fail	Overall Compliance: No
Severity Score: 13.75			
Codes/Mitigation Info/Possible Solution		Field Measurements/Component Compliance

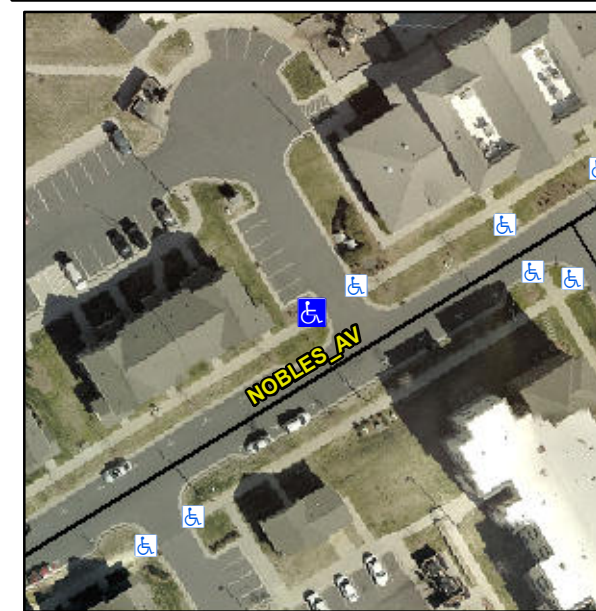
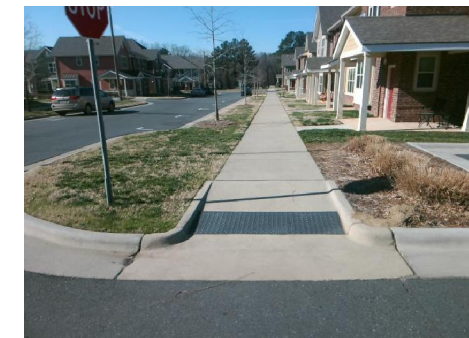
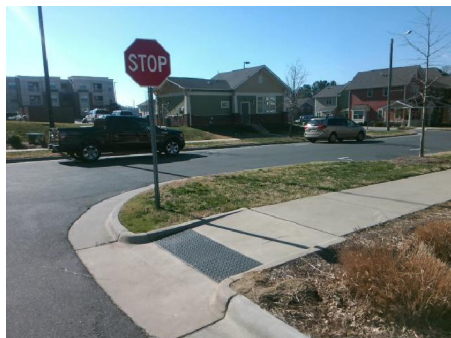
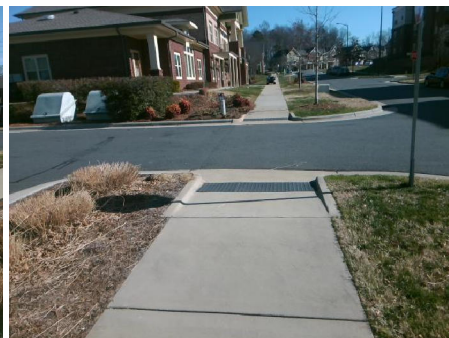
Compliance	Description	Data	Compliance	Description	Data
N/A	Ramp Length (in)	71.0	No	Ramp Slope (%)	8.9
Yes	Ramp Width (in)	70.0	No	Ramp XSlope (%)	4.0
N/A	Flare Type LT	N/A	N/A	Flare Type RT	N/A
N/A	Flare Slope LT (%)	N/A	N/A	Flare Slope RT (%)	N/A
N/A	Flare Traversable LT?	N/A	N/A	Flare Traversable RT?	N/A
N/A	Landing Length (in)	N/A	N/A	DWS Provided?	N/A
N/A	Landing Width (in)	N/A	N/A	DWS Contrast?	N/A
N/A	Landing Slope (%)	N/A	N/A	DWS Length (in)	N/A
N/A	Landing X Slope (%)	N/A	N/A	DWS Full Width?	N/A
N/A	Landing Curb? (Y/N)	N/A	N/A	DWS Offset (in)	N/A
N/A	Shared Landing?	N/A			
N/A	Gutter Ponding?	N/A	N/A	Gutter Slope (%)	N/A
N/A	Gutter Lip Ht (in)	N/A	N/A	Gutter X Slope (%)	N/A
N/A	Painted X Walk1?	No	N/A	Painted X Walk2?	N/A
	X Walk 1 Direction	To E		X Walk 2 Direction	N/A
N/A	X Walk 1 Width (in)	N/A	N/A	X Walk 2 Width (in)	N/A
	X Walk 1 Slope (%)	6.1		X Walk 2 Slope (%)	N/A
	X Walk 1 X Slope (%)	0.9		X Walk 2 X Slope (%)	N/A

N/A	Ramp inside XWalk1?	N/A	N/A	Ramp inside XWalk2?	N/A
	Road Slope (%)	N/A	N/A	Clear Space?	N/A
	Road X Slope (%)	N/A	N/A	Clear Space to XWalk (in)	N/A
N/A	Any Obstructions?	N/A	N/A	Storm Grate/Utility Hazard?	N/A
	Obstruction Type			Storm Grate/Utility Type	
		N/A			N/A
			Yes	Surface Condition? (G/P)	Good

**Remove & Replace Entire Ramp.**

**R304.2.2, R304.5.3**

Total Cost: \$ 1850.00
