Access Compliance Report

Public Rights-of-Way

(Curb Ramps)

Intersection ID: 17802	Main Street: HAVEN_DR	Cross Street: REECE_RD	Location: NE
ADA ID: 907272A3469C	Ramp Type: PerpDiag	Initial Pass/Fail: Fail	Overall Compliance: No
Severity Score: 8.75			
Codes/Mitigation Info/Possible Solution		Field Measurements/Component Compliance

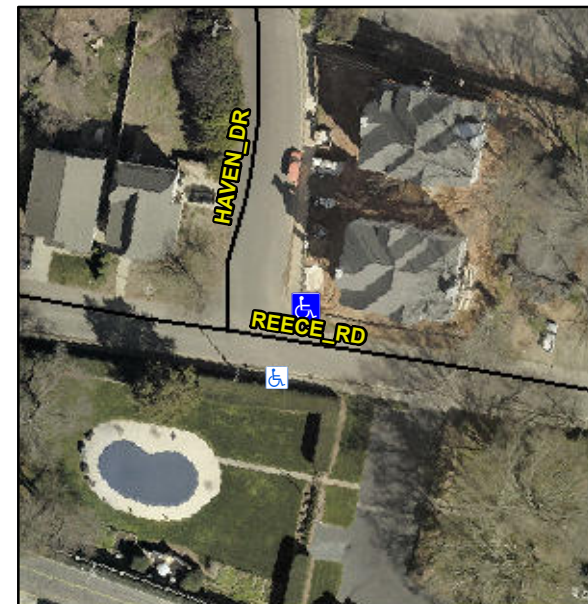
Not Found, R304.5.1

Compliance	Description	Data	Compliance	Description	Data
N/A	Ramp Length (in)	71.0	Yes	Ramp Slope (%)	5.3
No	Ramp Width (in)	44.0	Yes	Ramp XSlope (%)	0.7
N/A	Flare Type LT	N/A	N/A	Flare Type RT	N/A
N/A	Flare Slope LT (%)	N/A	N/A	Flare Slope RT (%)	N/A
N/A	Flare Traversable LT?	N/A	N/A	Flare Traversable RT?	N/A
N/A	Landing Length (in)	N/A	N/A	DWS Provided?	N/A
N/A	Landing Width (in)	N/A	N/A	DWS Contrast?	N/A
N/A	Landing Slope (%)	N/A	N/A	DWS Length (in)	N/A
N/A	Landing X Slope (%)	N/A	N/A	DWS Full Width?	N/A
N/A	Landing Curb? (Y/N)	N/A	N/A	DWS Offset (in)	N/A
N/A	Shared Landing?	N/A			
N/A	Gutter Ponding?	N/A	N/A	Gutter Slope (%)	N/A
N/A	Gutter Lip Ht (in)	N/A	N/A	Gutter X Slope (%)	N/A
N/A	Painted X Walk1?	No	N/A	Painted X Walk2?	No
	X Walk 1 Direction	To NW		X Walk 2 Direction	To S
N/A	X Walk 1 Width (in)	N/A	N/A	X Walk 2 Width (in)	N/A
	X Walk 1 Slope (%)	3.2		X Walk 2 Slope (%)	2.0
	X Walk 1 X Slope (%)	2.5		X Walk 2 X Slope (%)	0.6

N/A	Ramp inside XWalk1?	N/A	N/A	Ramp inside XWalk2?	N/A
	Road Slope (%)	0.5	N/A	Clear Space?	N/A
	Road X Slope (%)	1.8	N/A	Clear Space to XWalk (in)	N/A
N/A	Any Obstructions?	N/A	N/A	Storm Grate/Utility Hazard?	N/A
	Obstruction Type			Storm Grate/Utility Type	
		N/A			N/A
			Yes	Surface Condition? (G/P)	Good

Possible Solutions:

Remove & Replace Curb Ramp With Two New Directional Ramps or Equivalent.
