Access Compliance Report

Public Rights-of-Way

(Curb Ramps)

Intersection ID: 53912	Main Street: BRITTONDALE_LN	Cross Street: PINYON_PINE_LN	Location: NE
ADA ID: 90770337FD85	Ramp Type: PerpDiag	Initial Pass/Fail: Fail	Overall Compliance: No
		Severity Score: 10

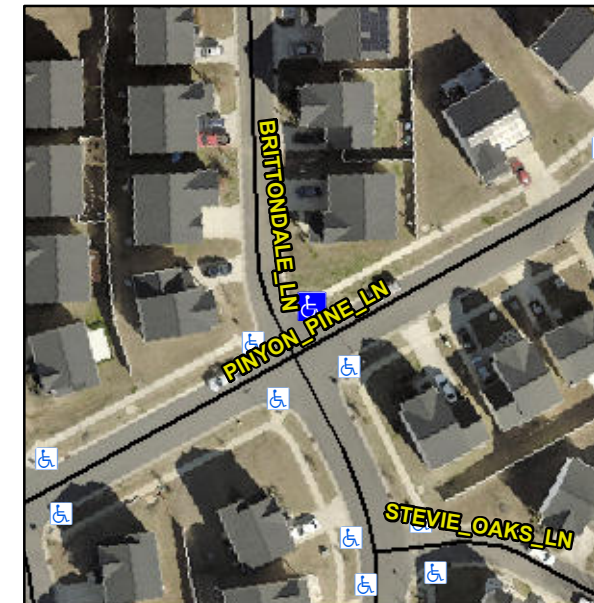
Compliance	Description	Data	Compliance	Description	Data
N/A	Ramp Length (in)	101.0	Yes	Ramp Slope (%)	5.2
No	Ramp Width (in)	42.5	No	Ramp XSlope (%)	2.7
N/A	Flare Type LT	N/A	N/A	Flare Type RT	N/A
N/A	Flare Slope LT (%)	N/A	N/A	Flare Slope RT (%)	N/A
N/A	Flare Traversable LT?	N/A	N/A	Flare Traversable RT?	N/A
N/A	Landing Length (in)	N/A	N/A	DWS Provided?	N/A
N/A	Landing Width (in)	N/A	N/A	DWS Contrast?	N/A
N/A	Landing Slope (%)	N/A	N/A	DWS Length (in)	N/A
N/A	Landing X Slope (%)	N/A	N/A	DWS Full Width?	N/A
N/A	Landing Curb? (Y/N)	N/A	N/A	DWS Offset (in)	N/A
N/A	Shared Landing?	N/A			
N/A	Gutter Ponding?	N/A	N/A	Gutter Slope (%)	N/A
N/A	Gutter Lip Ht (in)	N/A	N/A	Gutter X Slope (%)	N/A
N/A	Painted X Walk1?	No	N/A	Painted X Walk2?	No
	X Walk 1 Direction	To W		X Walk 2 Direction	To S
N/A	X Walk 1 Width (in)	N/A	N/A	X Walk 2 Width (in)	N/A
	X Walk 1 Slope (%)	5.3		X Walk 2 Slope (%)	6.0
	X Walk 1 X Slope (%)	3.8		X Walk 2 X Slope (%)	2.3

N/A	Ramp inside XWalk1?	N/A	N/A	Ramp inside XWalk2?	N/A
	Road Slope (%)	3.6	N/A	Clear Space?	N/A
	Road X Slope (%)	8.6	N/A	Clear Space to XWalk (in)	N/A
N/A	Any Obstructions?	N/A	N/A	Storm Grate/Utility Hazard?	N/A
	Obstruction Type			Storm Grate/Utility Type	
		N/A			N/A
			Yes	Surface Condition? (G/P)	Good

Remove & Replace Curb Ramp With Two New Directional Ramps or Equivalent.

Not Found, R304.5.1, R304.5.3
