# Access Compliance Report

## Public Rights-of-Way

### (Curb Ramps)

| Intersection ID: 42453 | Main Street: KINGSLEY_VIEW_DR | Cross Street: ROYAL_CASTLE_CT | Location: N |

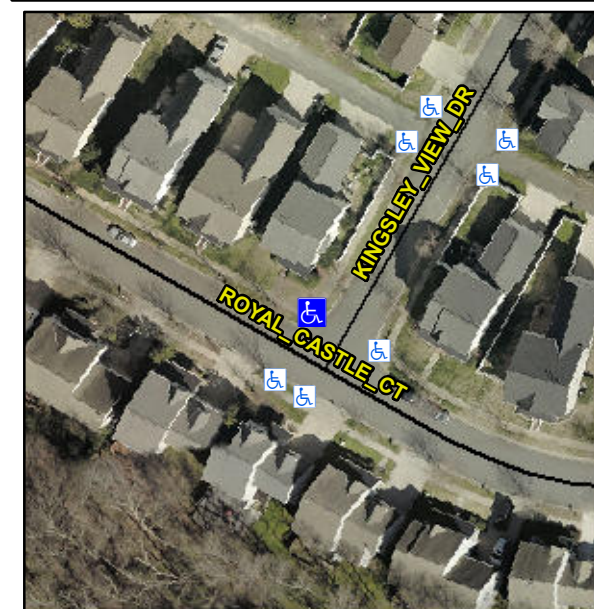
**R304.5.1, R304.2.2, R304.5.3**

| Compliance | Description | Data | Compliance | Description | Data |
|---|---|---|---|---|---|
| N/A | Ramp Length (in) | 60.0 | No | Ramp Slope (%) | 11.1 |
| No | Ramp Width (in) | 46.0 | No | Ramp XSlope (%) | 6.3 |

**Remove & Replace Curb Ramp With Two New Directional Ramps or Equivalent.**

Total Cost: \$ 3200.00
