# Access Compliance Report

## Public Rights-of-Way

### (Curb Ramps)

| Intersection ID: 53122 | Main Street: CROCKETT_PARK_PL | Cross Street: IVERSON_WY | Location: E |

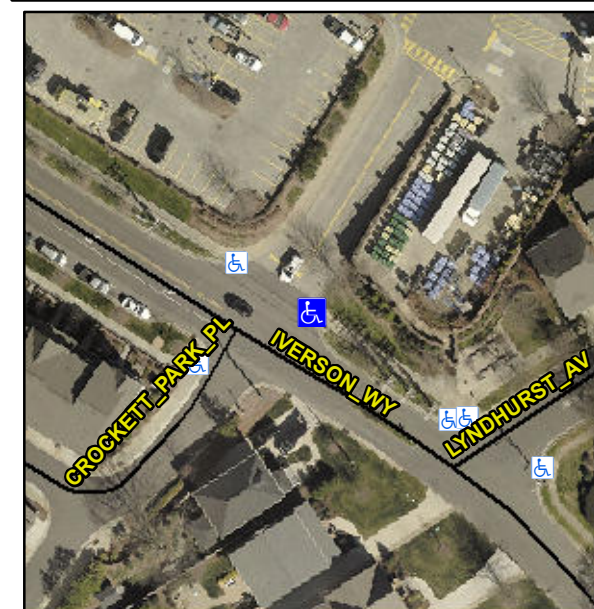
| ADA ID: 908F816B0D53 | Ramp Type: PerpDiag | Initial Pass/Fail: Fail | Overall Compliance: No |
| Severity Score: 13.75 | | | |

**Not Found, R304.2.2, R304.5.3**

| Compliance | Description | Data | Compliance | Description | Data |
|---|---|---|---|---|---|
| N/A | Ramp Length (in) | 74.0 | No | Ramp Slope (%) | 8.8 |
| Yes | Ramp Width (in) | 48.0 | No | Ramp XSlope (%) | 3.0 |

**Remove & Replace Curb Ramp With Two New Directional Ramps or Equivalent.**

Total Cost: \$ 3200.00
