# Access Compliance Report

## Public Rights-of-Way

### (Curb Ramps)

Intersection ID: 13782	Main Street: CENTRAL_AV	Cross Street: MEDFORD_DR	Location: SE
ADA ID: 90911E559B20	Ramp Type: Perp	Initial Pass/Fail: Fail	Overall Compliance: No
Severity Score: 18.75			
Codes/Mitigation Info/Possible Solution		Field Measurements/Component Compliance

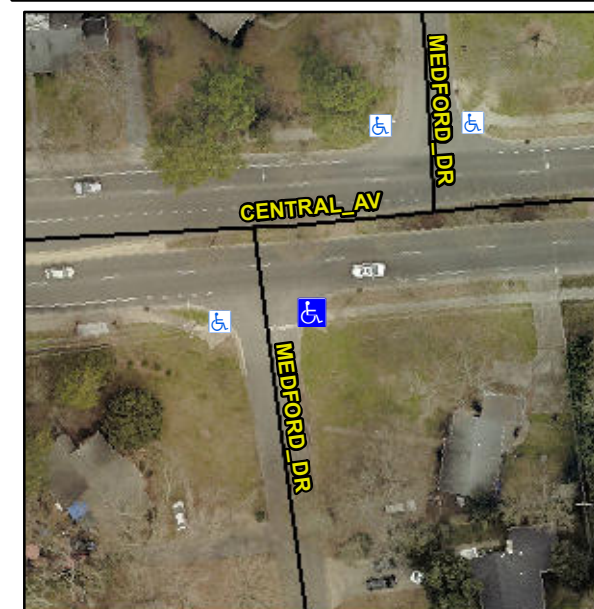
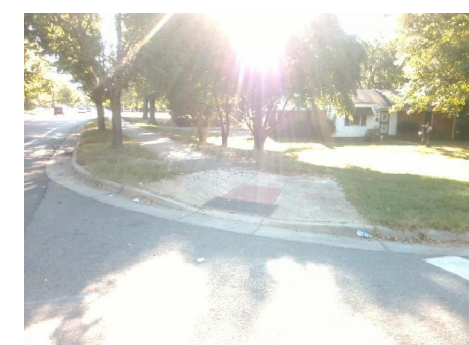
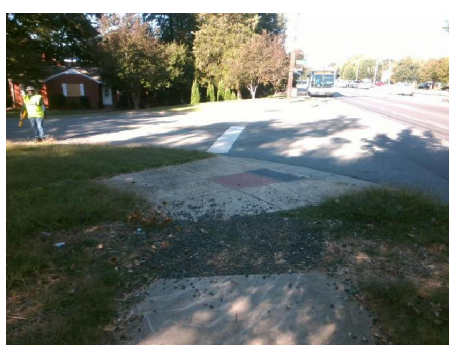
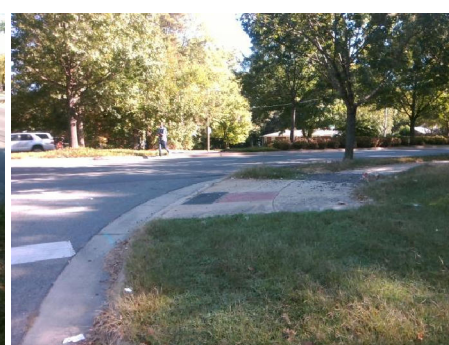
**Not Found, R304.5.1, R304.5.3**

Compliance	Description	Data	Compliance	Description	Data
N/A	Ramp Length (in)	72.0	Yes	Ramp Slope (%)	6.0
No	Ramp Width (in)	35.0	No	Ramp XSlope (%)	3.6
N/A	Flare Type LT	N/A	N/A	Flare Type RT	N/A
N/A	Flare Slope LT (%)	N/A	N/A	Flare Slope RT (%)	N/A
N/A	Flare Traversable LT?	N/A	N/A	Flare Traversable RT?	N/A
N/A	Landing Length (in)	N/A	N/A	DWS Provided?	N/A
N/A	Landing Width (in)	N/A	N/A	DWS Contrast?	N/A
N/A	Landing Slope (%)	N/A	N/A	DWS Length (in)	N/A
N/A	Landing X Slope (%)	N/A	N/A	DWS Full Width?	N/A
N/A	Landing Curb? (Y/N)	N/A	N/A	DWS Offset (in)	N/A
N/A	Shared Landing?	N/A			
N/A	Gutter Ponding?	N/A	N/A	Gutter Slope (%)	N/A
N/A	Gutter Lip Ht (in)	N/A	N/A	Gutter X Slope (%)	N/A
N/A	Painted X Walk1?	No	N/A	Painted X Walk2?	N/A
	X Walk 1 Direction	To W		X Walk 2 Direction	N/A
N/A	X Walk 1 Width (in)	N/A	N/A	X Walk 2 Width (in)	N/A
	X Walk 1 Slope (%)	1.3		X Walk 2 Slope (%)	N/A
	X Walk 1 X Slope (%)	5.8		X Walk 2 X Slope (%)	N/A

N/A	Ramp inside XWalk1?	N/A	N/A	Ramp inside XWalk2?	N/A
	Road Slope (%)	N/A	N/A	Clear Space?	N/A
	Road X Slope (%)	N/A	N/A	Clear Space to XWalk (in)	N/A
N/A	Any Obstructions?	N/A	N/A	Storm Grate/Utility Hazard?	N/A
	Obstruction Type			Storm Grate/Utility Type	
		N/A			N/A
			Yes	Surface Condition? (G/P)	Good

**Remove & Replace Entire Ramp.**
