Access Compliance Report

Public Rights-of-Way

(Curb Ramps)

Intersection ID: 9183	Main Street: CONDON_ST	Cross Street: VINTON_ST	Location: SW
ADA ID: 9091AB7E3A1E	Ramp Type: BlendTrans1	Initial Pass/Fail: Pass	Overall Compliance: No
Severity Score: 5			
Codes/Mitigation Info/Possible Solution		Field Measurements/Component Compliance

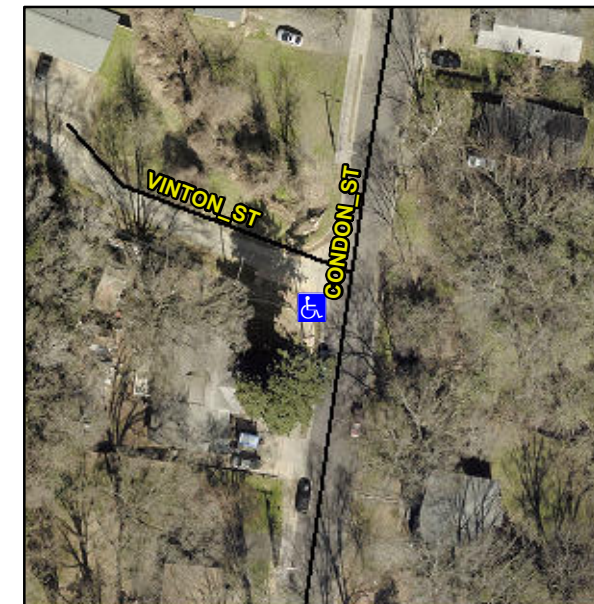
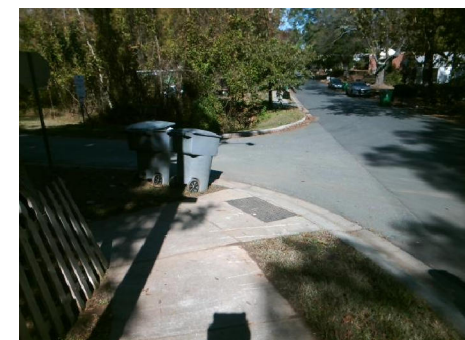
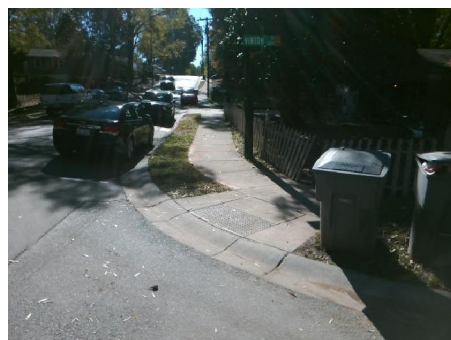
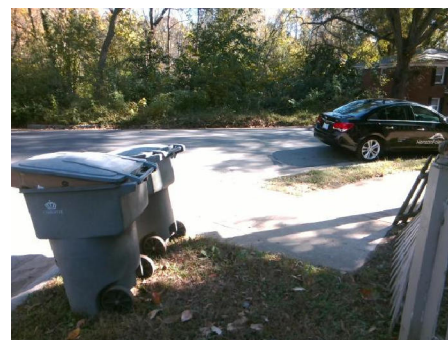
Not Found, R304.5.4

Compliance	Description	Data	Compliance	Description	Data
N/A	Ramp Length (in)	53.0	Yes	BlendTrans Slope (%)	3.3
Yes	Ramp Width (in)	48.0	Yes	BlendTrans XSlope (%)	1.1
N/A	Flare Type LT	Sloped	N/A	Flare Type RT	Sloped
N/A	Flare Slope LT (%)	2.7	N/A	Flare Slope RT (%)	0.2
N/A	Flare Traversable LT?	No	N/A	Flare Traversable RT?	No
Yes	Landing Length (in)	59.0	Yes	DWS Provided?	Yes
Yes	Landing Width (in)	48.0	Yes	DWS Contrast?	Yes
Yes	Landing Slope (%)	1.2	Yes	DWS Length (in)	24.0
Yes	Landing X Slope (%)	1.9	Yes	DWS Full Width?	Yes
N/A	Landing Curb? (Y/N)	No	Yes	DWS Offset (in)	2.0
N/A	Shared Landing?	No			
Yes	Gutter Ponding?	No	No	Gutter Slope (%)	5.7
Yes	Gutter Lip Ht (in)	0.0	Yes	Gutter X Slope (%)	1.8
N/A	Painted X Walk1?	No	N/A	Painted X Walk2?	N/A
	X Walk 1 Direction	To N		X Walk 2 Direction	N/A
	X Walk 1 Width (in)	N/A		X Walk 2 Width (in)	N/A
	X Walk 1 Slope (%)	0.3		X Walk 2 Slope (%)	N/A
	X Walk 1 X Slope (%)	2.0		X Walk 2 X Slope (%)	N/A

N/A	Ramp inside XWalk1?	N/A	N/A	Ramp inside XWalk2?	N/A
	Road Slope (%)	2.0		Clear Space?	Yes
	Road X Slope (%)	0.3	N/A	Clear Space to XWalk (in)	N/A
Yes	Any Obstructions?	No	Yes	Storm Grate/Utility Hazard?	No
	Obstruction Type			Storm Grate/Utility Type	
			N/A		N/A
			Yes	Surface Condition? (G/P)	Good
			No	Curb Slope (%)	27.5

Possible Solutions:

Remove & Replace Curb Slope and Extend Ramp. Remove & Replace Gutter.
