Access Compliance Report

Public Rights-of-Way

(Curb Ramps)

Intersection ID: 25263	Main Street: CARPENTER_DR	Cross Street: SHADOWLAKE_DR	Location: W
ADA ID: 909AEB3889D5	Ramp Type: Directional1	Initial Pass/Fail: Fail	Overall Compliance: No
Severity Score: 13.75			
Codes/Mitigation Info/Possible Solution		Field Measurements/Component Compliance

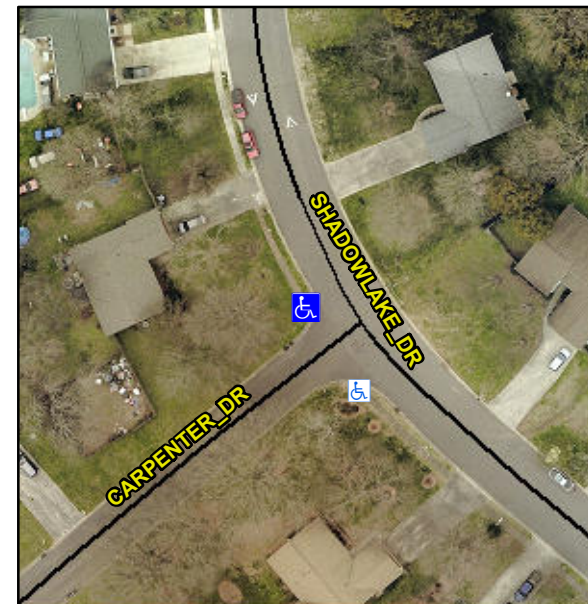
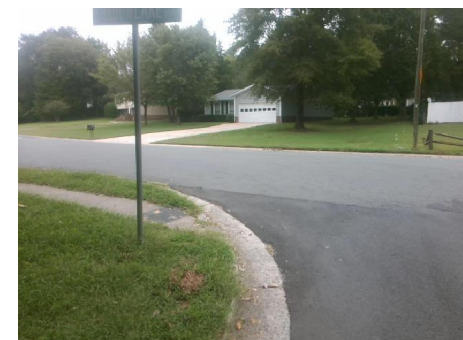
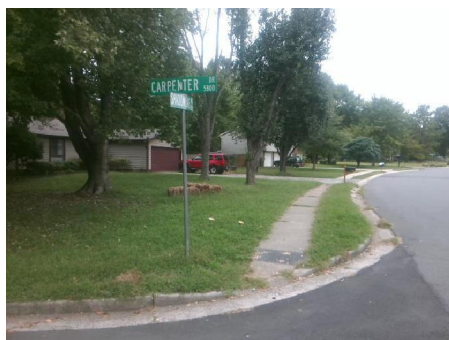
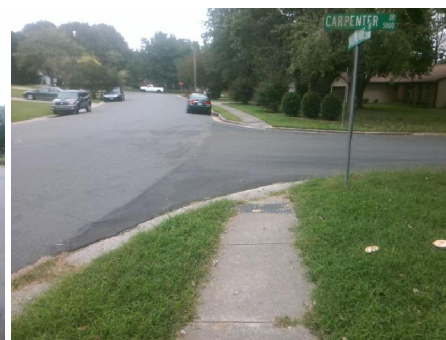
R304.2.2, R304.5.3

Compliance	Description	Data	Compliance	Description	Data
N/A	Ramp Length (in)	67.0	N/A	Grade Break?	N/A
Yes	Ramp Width (in)	48.0	N/A	Grade Break Slope (%)	0.0
No	Ramp Slope (%)	10.7	N/A	Grade Break XSlope (%)	0.0
No	Ramp XSlope (%)	2.4			
N/A	Flare Type LT	N/A	N/A	Flare Type RT	N/A
N/A	Flare Slope LT (%)	N/A	N/A	Flare Slope RT (%)	0.0
N/A	Flare Traversable LT?	N/A	N/A	Flare Traversable RT?	N/A
N/A	Landing Length (in)	0.0	N/A	DWS Provided?	N/A
N/A	Landing Width (in)	0.0	N/A	DWS Contrast?	N/A
N/A	Landing Slope (%)	0.0	N/A	DWS Length (in)	N/A
N/A	Landing X Slope (%)	0.0	N/A	DWS Full Width?	N/A
N/A	Landing Curb? (Y/N)	N/A	N/A	DWS Offset LT (in)	N/A
N/A	Shared Landing?	N/A	N/A	DWS Offset RT (in)	N/A
N/A	Gutter Ponding?	0.0	N/A	Gutter Slope (%)	N/A
N/A	Gutter Lip Ht (in)	0.0	N/A	Gutter X Slope (%)	N/A
N/A	Painted X Walk1?	No		Road Slope (%)	4.2
	X Walk 1 Direction	To SE		Road X Slope (%)	8.1
	X Walk 1 Width (in)	N/A		Clear Space?	N/A

X Walk 1 Slope (%)	4.2	N/A	Clear Space to XWalk (in)	N/A
	X Walk 1 X Slope (%)	8.1	N/A	Storm Grate/Utility Hazard?	N/A
N/A	Ramp inside XWalk1?	N/A		Storm Grate/Utility Type	
N/A	Any Obstructions?	N/A			N/A
	Obstruction Type		Yes	Surface Condition? (G/P)	Good
			N/A	Curb Slope (%)	22.9

Possible Solutions:

Remove & Replace Entire Ramp.
