Access Compliance Report

Public Rights-of-Way

(Curb Ramps)

Intersection ID: 24385	Main Street: BEVERLY_CREST_BV	Cross Street: BECKMORE_PL	Location: NE
ADA ID: 909EBDD98FB6	Ramp Type: PerpDiag	Initial Pass/Fail: Fail	Overall Compliance: No
Severity Score: 21.25			
Codes/Mitigation Info/Possible Solution		Field Measurements/Component Compliance

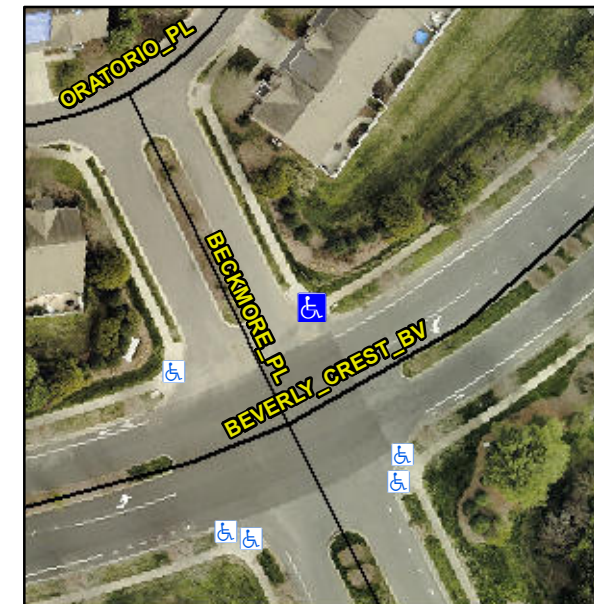
Not Found, R304.5.1, R304.2.2

Compliance	Description	Data	Compliance	Description	Data
N/A	Ramp Length (in)	104.0	No	Ramp Slope (%)	8.7
No	Ramp Width (in)	46.0	Yes	Ramp XSlope (%)	0.0
N/A	Flare Type LT	N/A	N/A	Flare Type RT	N/A
N/A	Flare Slope LT (%)	N/A	N/A	Flare Slope RT (%)	N/A
N/A	Flare Traversable LT?	N/A	N/A	Flare Traversable RT?	N/A
N/A	Landing Length (in)	N/A	N/A	DWS Provided?	N/A
N/A	Landing Width (in)	N/A	N/A	DWS Contrast?	N/A
N/A	Landing Slope (%)	N/A	N/A	DWS Length (in)	N/A
N/A	Landing X Slope (%)	N/A	N/A	DWS Full Width?	N/A
N/A	Landing Curb? (Y/N)	N/A	N/A	DWS Offset (in)	N/A
N/A	Shared Landing?	N/A			
N/A	Gutter Ponding?	N/A	N/A	Gutter Slope (%)	N/A
N/A	Gutter Lip Ht (in)	N/A	N/A	Gutter X Slope (%)	N/A
N/A	Painted X Walk1?	No	N/A	Painted X Walk2?	No
	X Walk 1 Direction	To W		X Walk 2 Direction	To S
N/A	X Walk 1 Width (in)	N/A	N/A	X Walk 2 Width (in)	N/A
	X Walk 1 Slope (%)	1.5		X Walk 2 Slope (%)	1.5
	X Walk 1 X Slope (%)	0.9		X Walk 2 X Slope (%)	2.6

N/A	Ramp inside XWalk1?	N/A	N/A	Ramp inside XWalk2?	N/A
	Road Slope (%)	0.3	N/A	Clear Space?	N/A
	Road X Slope (%)	1.3	N/A	Clear Space to XWalk (in)	N/A
N/A	Any Obstructions?	N/A	N/A	Storm Grate/Utility Hazard?	N/A
	Obstruction Type			Storm Grate/Utility Type	
		N/A			N/A
			Yes	Surface Condition? (G/P)	Good

Possible Solutions:

Remove & Replace Curb Ramp With Two New Directional Ramps or Equivalent.
