Access Compliance Report Public Rights-of-Way (Curb Ramps)

Intersection ID: 21842 Main Street: HARTMILL_CT Cross Street: SHARON_VIEW_RD Location: S

ADA ID: 90A178EB31B4 Ramp Type: PerpDiag Initial Pass/Fail: Fail Overall Compliance: No Severity Score: 25

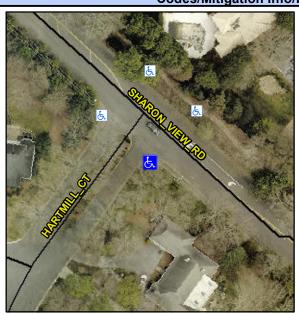
Field Measure	ements/Co	<u>ompo</u>	nent Compliance	
Compliance Description		Data	Compliance Description		Data
N/A	Ramp Length (in)	58.0	Yes	Ramp Slope (%)	8.3
Yes	Ramp Width (in)	48.0	No	Ramp XSlope (%)	8.4
N/A	Flare Type LT	N/A	N/A	Flare Type RT	N/A
N/A	Flare Slope LT (%)	N/A	N/A	Flare Slope RT (%)	N/A
N/A	Flare Traversable LT?	N/A	N/A	Flare Traversable RT?	N/A
N/A	Landing Length (in)	N/A	N/A	DWS Provided?	N/A
N/A	Landing Width (in)	N/A	N/A	DWS Contrast?	N/A
N/A	Landing Slope (%)	N/A	N/A	DWS Length (in)	N/A
N/A	Landing X Slope (%)	N/A	N/A	DWS Full Width?	N/A
N/A	Landing Curb? (Y/N)	N/A	N/A	DWS Offset (in)	N/A
N/A	Shared Landing?	N/A			
N/A	Gutter Ponding?	N/A	N/A	Gutter Slope (%)	N/A
N/A	Gutter Lip Ht (in)	N/A	N/A	Gutter X Slope (%)	N/A
N/A	Painted X Walk1?	No	N/A	Painted X Walk2?	No
	X Walk 1 Direction	To NE		X Walk 2 Direction	To NW
N/A	X Walk 1 Width (in)	N/A	N/A	X Walk 2 Width (in)	N/A
	X Walk 1 Slope (%)	0.2		X Walk 2 Slope (%)	3.0

X Walk 1 X Slope (%)	4.4		X Walk 2 X Slope (%)	7.6
N/A	Ramp inside XWalk1?	N/A	N/A	Ramp inside XWalk2?	N/A
	Road Slope (%)	6.8	N/A	Clear Space?	N/A
	Road X Slope (%)	3.3	N/A	Clear Space to XWalk (in)	N/A
N/A	Any Obstructions?	N/A	N/A	Storm Grate/Utility Hazard?	N/A

Remove & Replace Curb Ramp With
Two New Directional Ramps or
Equivalent.

R304.5.3

Total Cost: \$ 3200.00
