Access Compliance Report

Public Rights-of-Way

(Curb Ramps)

Intersection ID: 10026312	Main Street: FAIRVIEW_RD	Cross Street: N/A	Location: SW
ADA ID: 90A2806C10E9	Ramp Type: PerpDiag	Initial Pass/Fail: Fail	Overall Compliance: No
Severity Score: 10			
Codes/Mitigation Info/Possible Solution		Field Measurements/Component Compliance

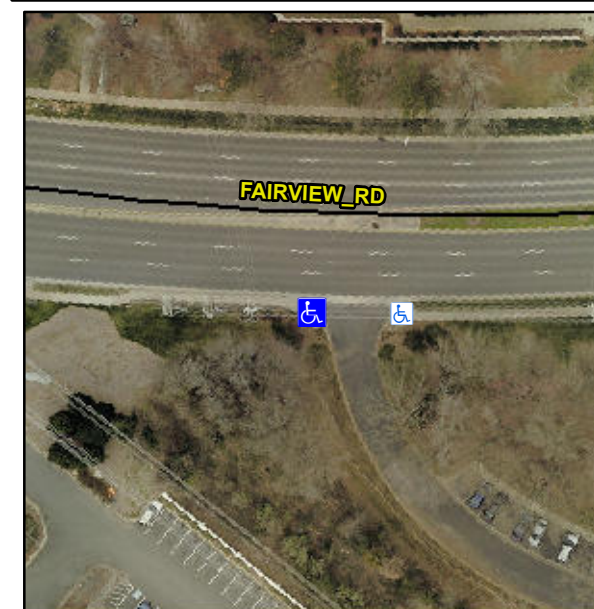
R304.5.1, R304.5.3

Compliance	Description	Data	Compliance	Description	Data
N/A	Ramp Length (in)	61.0	Yes	Ramp Slope (%)	5.9
No	Ramp Width (in)	37.0	No	Ramp XSlope (%)	2.6
N/A	Flare Type LT	N/A	N/A	Flare Type RT	N/A
N/A	Flare Slope LT (%)	N/A	N/A	Flare Slope RT (%)	N/A
N/A	Flare Traversable LT?	N/A	N/A	Flare Traversable RT?	N/A
N/A	Landing Length (in)	N/A	N/A	DWS Provided?	N/A
N/A	Landing Width (in)	N/A	N/A	DWS Contrast?	N/A
N/A	Landing Slope (%)	N/A	N/A	DWS Length (in)	N/A
N/A	Landing X Slope (%)	N/A	N/A	DWS Full Width?	N/A
N/A	Landing Curb? (Y/N)	N/A	N/A	DWS Offset (in)	N/A
N/A	Shared Landing?	N/A			
N/A	Gutter Ponding?	N/A	N/A	Gutter Slope (%)	N/A
N/A	Gutter Lip Ht (in)	N/A	N/A	Gutter X Slope (%)	N/A
N/A	Painted X Walk1?	No	N/A	Painted X Walk2?	No
	X Walk 1 Direction	To E		X Walk 2 Direction	To N
N/A	X Walk 1 Width (in)	N/A	N/A	X Walk 2 Width (in)	N/A
	X Walk 1 Slope (%)	5.6		X Walk 2 Slope (%)	5.4
	X Walk 1 X Slope (%)	2.4		X Walk 2 X Slope (%)	3.6

N/A	Ramp inside XWalk1?	N/A	N/A	Ramp inside XWalk2?	N/A
	Road Slope (%)	0.3	N/A	Clear Space?	N/A
	Road X Slope (%)	4.3	N/A	Clear Space to XWalk (in)	N/A
N/A	Any Obstructions?	N/A	N/A	Storm Grate/Utility Hazard?	N/A
	Obstruction Type			Storm Grate/Utility Type	
		N/A			N/A
			Yes	Surface Condition? (G/P)	Good

Remove & Replace Curb Ramp With Two New Directional Ramps or Equivalent.
