# Access Compliance Report

## Public Rights-of-Way

| Intersection ID: 47614 | Main Street: WYALONG_DR | Cross Street: MACQUARIE_LN | Location: NE |
| ADA ID: 90A3F4B36ED5 | Ramp Type: BlendTrans1 | Initial Pass/Fail: Fail | Overall Compliance: No |

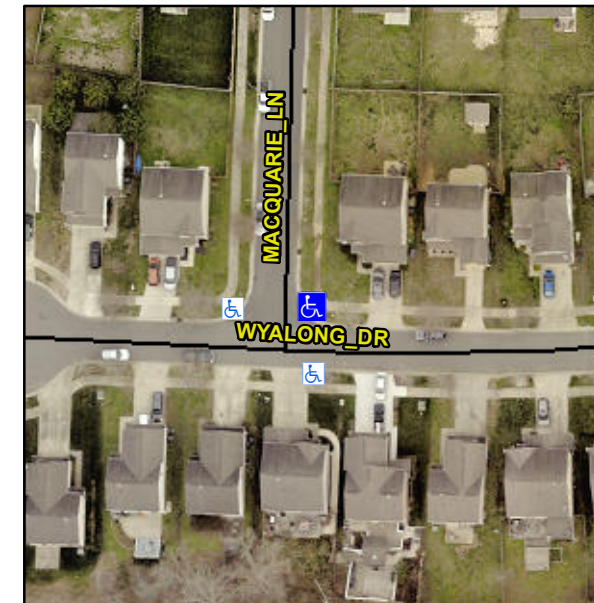
| | | Severity Score: 12.5 | |

**Not Found, R304.5.3**

| Compliance | Description | Data | Compliance | Description | Data |
|---|---|---|---|---|---|
| Yes | Ramp Width (in) | 48.0 | No | BlendTrans XSlope (%) | 5.1 |
| | | | No | Curb Slope (%) | 12.5 |

**Remove & Replace Curb Ramp With Two New Directional Ramps or Equivalent.**

Total Cost: \$ 3200.00
