# Access Compliance Report

## Public Rights-of-Way

### (Curb Ramps)

| Intersection ID: 7289 | Main Street: GLORYLAND_AV | Cross Street: N_TRYON_ST | Location: NE |

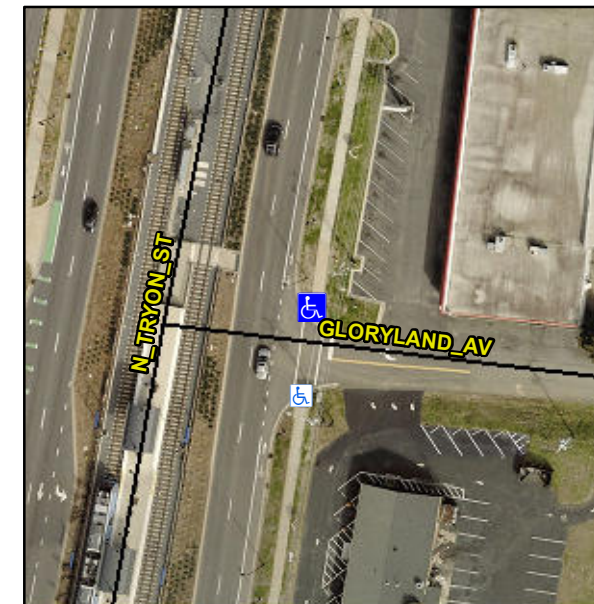
| ADA ID: 90A60A326A57 | Ramp Type: Directional1 | Initial Pass/Fail: Fail | Overall Compliance: No |
| | | Severity Score: 12.5 | |

**R304.2.2**

| Compliance | Description | Data | Compliance | Description | Data |
|---|---|---|---|---|---|
| No | Ramp Slope (%) | 9.1 | N/A | Grade Break XSlope (%) | 0.0 |

**Remove & Replace Entire Ramp.**
