Access Compliance Report

Public Rights-of-Way

(Curb Ramps)

Intersection ID: 10025367	Main Street: E_8TH_ST	Cross Street: N/A	Location: NE
ADA ID: 90B27174B8B7	Ramp Type: BlendTrans2	Initial Pass/Fail: Pass	Overall Compliance: No
Severity Score: 0			
Codes/Mitigation Info/Possible Solution		Field Measurements/Component Compliance

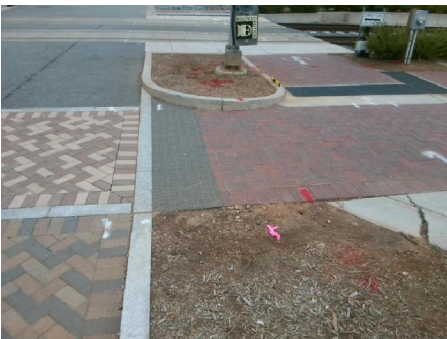
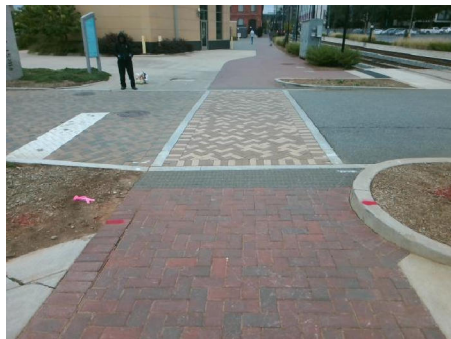
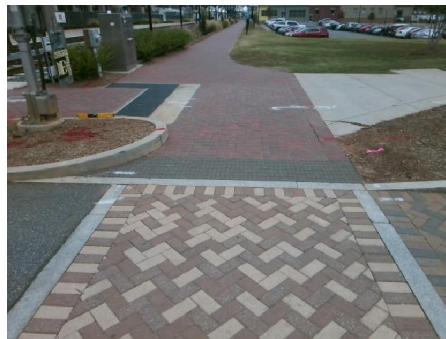
Compliance	Description	Data	Compliance	Description	Data
N/A	Ramp Length (in)	62.0	Yes	BlendTrans Slope (%)	2.5
Yes	Ramp Width (in)	99.0	Yes	BlendTrans XSlope (%)	0.8
Yes	Flare Type LT	Curbed_NoWalkSurface	N/A	Flare Type RT	None
N/A	Flare Slope LT (%)	N/A	N/A	Flare Slope RT (%)	N/A
N/A	Flare Traversable LT?	No	N/A	Flare Traversable RT?	N/A
N/A	Landing Length (in)	N/A	Yes	DWS Provided?	Yes
N/A	Landing Width (in)	N/A	Yes	DWS Contrast?	Yes
N/A	Landing Slope (%)	N/A	Yes	DWS Length (in)	24.0
N/A	Landing X Slope (%)	N/A	Yes	DWS Full Width?	Yes
N/A	Landing Curb? (Y/N)	No	Yes	DWS Offset (in)	0.0
N/A	Shared Landing?	No			
Yes	Gutter Ponding?	No	Yes	Gutter Slope (%)	1.3
Yes	Gutter Lip Ht (in)	0.0	No	Gutter X Slope (%)	2.3
N/A	Painted X Walk1?	Yes	N/A	Painted X Walk2?	N/A
	X Walk 1 Direction	To SW		X Walk 2 Direction	N/A
	X Walk 1 Width (in)	90.0		X Walk 2 Width (in)	N/A
	X Walk 1 Slope (%)	0.5		X Walk 2 Slope (%)	N/A

X Walk 1 X Slope (%)	1.8		X Walk 2 X Slope (%)	N/A
Yes	Ramp inside XWalk1?	Yes	N/A	Ramp inside XWalk2?	N/A
	Road Slope (%)	1.8		Clear Space?	Yes
	Road X Slope (%)	0.5	N/A	Clear Space to XWalk (in)	N/A
Yes	Any Obstructions?	No	Yes	Storm Grate/Utility Hazard?	No
	Obstruction Type			Storm Grate/Utility Type	
		N/A			N/A
			Yes	Surface Condition? (G/P)	Good
			Yes	Curb Slope (%)	0.7

Possible Solutions:

Remove & Replace Gutter.

R304.5.3
