# Access Compliance Report

## Public Rights-of-Way

### (Curb Ramps)

| Intersection ID: 8258 | Main Street: ENGLEHARDT_ST | Cross Street: ENGLISH_DR | Location: NE |

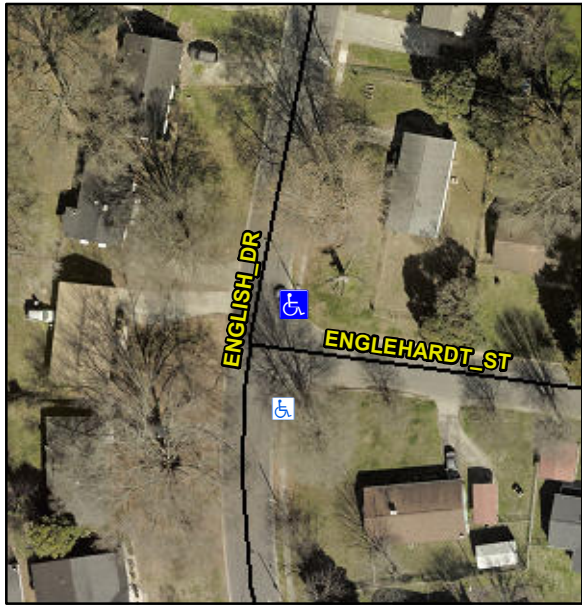
| ADA ID: 90B4E3D2261E | Ramp Type: BlendTrans1 | Initial Pass/Fail: Fail | Overall Compliance: No |

| Codes/Mitigation Info/Possible Solution | | | Field Measurements/Component Compliance | | | | | |
|---|---|--|---|---|---|---|---|---|
| | Remove & Replace Curb Ramp With Two New Directional Ramps or Equivalent. | | N/A | Ramp Length (in) | 30.0 | Yes | BlendTrans Slope (%) | 2.8 |
| | | | No | Ramp Width (in) | 33.0 | No | BlendTrans XSlope (%) | 2.4 |
| Not Found, R304.5.1, R304.5.3 | | | N/A | Gutter Lip Ht (in) | N/A | N/A | Gutter X Slope (%) | N/A |
| | | | | | | No | Curb Slope (%) | 19.7 |
