Access Compliance Report

Public Rights-of-Way

(Curb Ramps)

Intersection ID: 6377	Main Street: KATHERINE_KIKER_RD	Cross Street: KAYCE_LN	Location: NW
ADA ID: 90BB99217FFD	Ramp Type: Perp	Initial Pass/Fail: Fail	Overall Compliance: No
Severity Score: 12.5			
Codes/Mitigation Info/Possible Solution		Field Measurements/Component Compliance

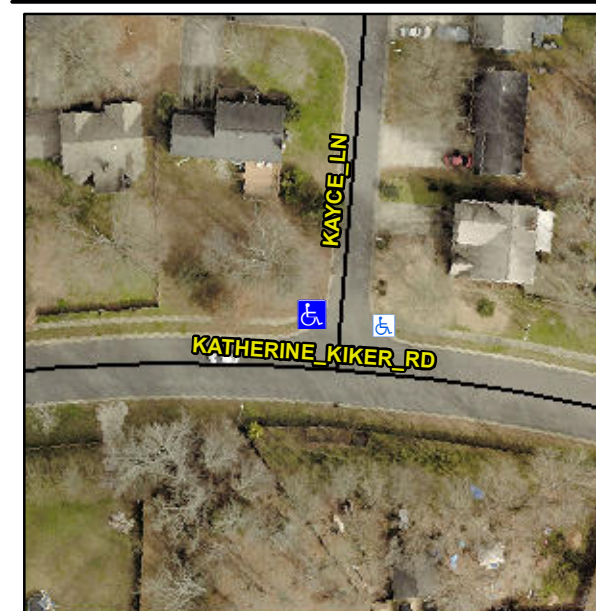
Not Found, R304.5.3

Compliance	Description	Data	Compliance	Description	Data
N/A	Ramp Length (in)	56.5	Yes	Ramp Slope (%)	6.9
Yes	Ramp Width (in)	50.0	No	Ramp XSlope (%)	6.3
N/A	Flare Type LT	N/A	N/A	Flare Type RT	N/A
N/A	Flare Slope LT (%)	N/A	N/A	Flare Slope RT (%)	N/A
N/A	Flare Traversable LT?	N/A	N/A	Flare Traversable RT?	N/A
N/A	Landing Length (in)	N/A	N/A	DWS Provided?	N/A
N/A	Landing Width (in)	N/A	N/A	DWS Contrast?	N/A
N/A	Landing Slope (%)	N/A	N/A	DWS Length (in)	N/A
N/A	Landing X Slope (%)	N/A	N/A	DWS Full Width?	N/A
N/A	Landing Curb? (Y/N)	N/A	N/A	DWS Offset (in)	N/A
N/A	Shared Landing?	N/A			
N/A	Gutter Ponding?	N/A	N/A	Gutter Slope (%)	N/A
N/A	Gutter Lip Ht (in)	N/A	N/A	Gutter X Slope (%)	N/A
N/A	Painted X Walk1?	No	N/A	Painted X Walk2?	N/A
	X Walk 1 Direction	To NE		X Walk 2 Direction	N/A
N/A	X Walk 1 Width (in)	N/A	N/A	X Walk 2 Width (in)	N/A
	X Walk 1 Slope (%)	3.6		X Walk 2 Slope (%)	N/A
	X Walk 1 X Slope (%)	7.2		X Walk 2 X Slope (%)	N/A

N/A	Ramp inside XWalk1?	N/A	N/A	Ramp inside XWalk2?	N/A
	Road Slope (%)	N/A	N/A	Clear Space?	N/A
	Road X Slope (%)	N/A	N/A	Clear Space to XWalk (in)	N/A
N/A	Any Obstructions?	N/A	N/A	Storm Grate/Utility Hazard?	N/A
	Obstruction Type			Storm Grate/Utility Type	
		N/A			N/A
		Yes		Surface Condition? (G/P)	Good

Possible Solutions:

Remove & Replace Entire Ramp.

Total Cost: \$ 1850.00
