Access Compliance Report

Public Rights-of-Way

(Curb Ramps)

Intersection ID: 32299		Main Street: HAZELVIEW_DR		Cross Street: OSWALD_LN		Location: NE			
ADA ID: 90C00FDCFCFC		Ramp Type: PerpDiag		Initial Pass/Fail: Fail		Overall Compliance: No		Severity Score: 30	
Codes/Mitigation Info/Possible Solution				Field Measurements/Component Compliance

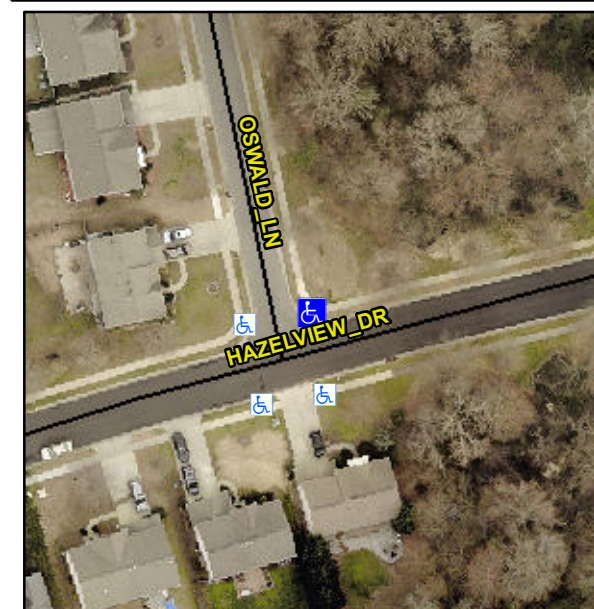
Not Found, R304.5.1, R304.2.2

Compliance	Description	Data	Compliance	Description	Data
N/A	Ramp Length (in)	55.5	No	Ramp Slope (%)	8.7
No	Ramp Width (in)	35.0	Yes	Ramp XSlope (%)	0.1
N/A	Flare Type LT	N/A	N/A	Flare Type RT	N/A
N/A	Flare Slope LT (%)	N/A	N/A	Flare Slope RT (%)	N/A
N/A	Flare Traversable LT?	N/A	N/A	Flare Traversable RT?	N/A
N/A	Landing Length (in)	N/A	N/A	DWS Provided?	N/A
N/A	Landing Width (in)	N/A	N/A	DWS Contrast?	N/A
N/A	Landing Slope (%)	N/A	N/A	DWS Length (in)	N/A
N/A	Landing X Slope (%)	N/A	N/A	DWS Full Width?	N/A
N/A	Landing Curb? (Y/N)	N/A	N/A	DWS Offset (in)	N/A
N/A	Shared Landing?	N/A			
N/A	Gutter Ponding?	N/A	N/A	Gutter Slope (%)	N/A
N/A	Gutter Lip Ht (in)	N/A	N/A	Gutter X Slope (%)	N/A
N/A	Painted X Walk1?	No	N/A	Painted X Walk2?	No
	X Walk 1 Direction	To W		X Walk 2 Direction	To S
N/A	X Walk 1 Width (in)	N/A	N/A	X Walk 2 Width (in)	N/A
	X Walk 1 Slope (%)	0.4		X Walk 2 Slope (%)	4.0
	X Walk 1 X Slope (%)	3.8		X Walk 2 X Slope (%)	0.8

N/A	Ramp inside XWalk1?	N/A	N/A	Ramp inside XWalk2?	N/A
	Road Slope (%)	1.1	N/A	Clear Space?	N/A
	Road X Slope (%)	2.2	N/A	Clear Space to XWalk (in)	N/A
N/A	Any Obstructions?	N/A	N/A	Storm Grate/Utility Hazard?	N/A
	Obstruction Type			Storm Grate/Utility Type	
		N/A			N/A
		Yes		Surface Condition? (G/P)	Good

Possible Solutions:

Remove & Replace Curb Ramp With Two New Directional Ramps or Equivalent.

Total Cost: \$ 3200.00
