## **Access Compliance Report Public Rights-of-Way** (Curb Ramps)

Intersection ID: 29801 Main Street: RUDOLPH DADEY DR **Cross Street: STEPHENSON CT** Location: SW ADA ID: 90C0C5AA2C41 Ramp Type: PerpDiag Initial Pass/Fail: Fail **Overall Compliance: No Severity Score:** 25

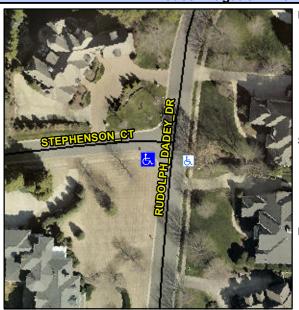
Not Found, R304.5.3

Compl	iance Description	Data	Compl	iance	Description	Data
N/A	Ramp Length (in)	48.0	Yes	Ramp	Slope (%)	6.2
Yes	Ramp Width (in)	48.0	No	Ramp	XSlope (%)	9.3
N/A	Flare Type LT	N/A	N/A	Flare	Type RT	N/A
N/A	Flare Slope LT (%)	N/A	N/A	Flare	Slope RT (%)	N/A
N/A	Flare Traversable LT?	N/A	N/A	Flare	Traversable RT?	N/A
N/A	Landing Length (in)	N/A	N/A	DWS	Provided?	N/A
N/A	Landing Width (in)	N/A	N/A	DWS	Contrast?	N/A
N/A	Landing Slope (%)	N/A	N/A	DWS	Length (in)	N/A
N/A	Landing X Slope (%)	N/A	N/A	DWS	Full Width?	N/A
N/A	Landing Curb? (Y/N)	N/A	N/A	DWS	Offset (in)	N/A
N/A	Shared Landing?	N/A				
N/A	Gutter Ponding?	N/A	N/A	Gutte	r Slope (%)	N/A
N/A	Gutter Lip Ht (in)	N/A	N/A	Gutte	r X Slope (%)	N/A
N/A	Painted X Walk1?	No	N/A	Paint	ed X Walk2?	No
	X Walk 1 Direction	To SE		X Wa	lk 2 Direction	To NE
N/A	X Walk 1 Width (in)	N/A	N/A	X Wa	lk 2 Width (in)	N/A
	X Walk 1 Slope (%)	5.2		X Wa	lk 2 Slope (%)	2.0
	X Walk 1 X Slope (%)	2.9		X Wa	lk 2 X Slope (%)	3.1

Possible Solutions: Remove & Replace Curb Ramp With Two New Directional Ramps or Equivalent. Surveyor Notes:
