Access Compliance Report

Public Rights-of-Way

(Curb Ramps)

Intersection ID: 10024552	Main Street: D_DUCKS_LN	Cross Street: N/A	Location: SE
ADA ID: 90C10206280F	Ramp Type: PerpDiag	Initial Pass/Fail: Fail	Overall Compliance: No
Codes/Mitigation Info/Possible Solution		Field Measurements/Component Compliance	
Severity Score: 46.25

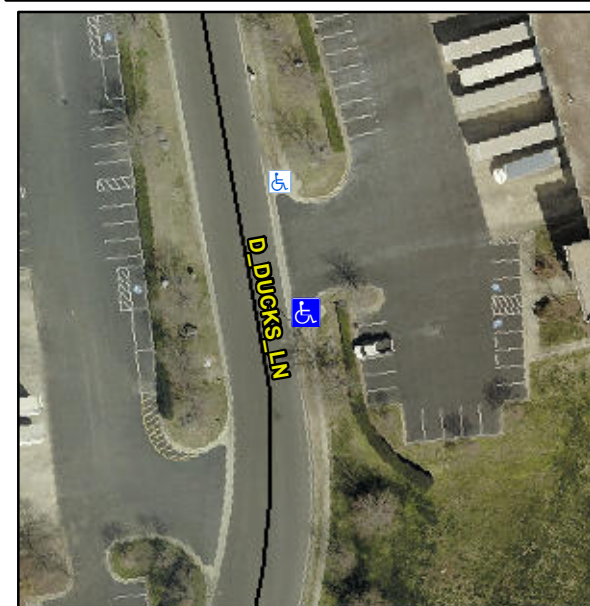
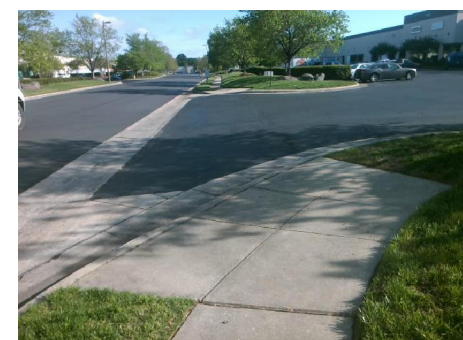
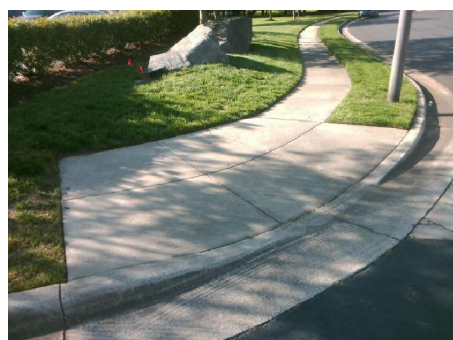
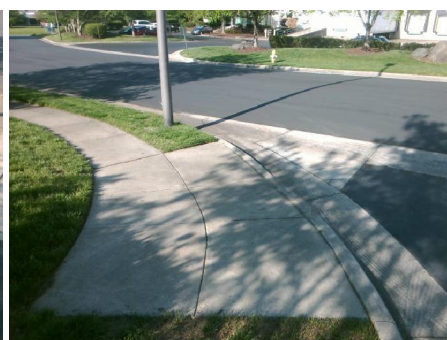
Not Found, R304.5.1, R304.2.2, R304.5.3

Compliance	Description	Data	Compliance	Description	Data
N/A	Ramp Length (in)	48.0	No	Ramp Slope (%)	8.9
No	Ramp Width (in)	40.0	No	Ramp XSlope (%)	8.7
N/A	Flare Type LT	N/A	N/A	Flare Type RT	N/A
N/A	Flare Slope LT (%)	N/A	N/A	Flare Slope RT (%)	N/A
N/A	Flare Traversable LT?	N/A	N/A	Flare Traversable RT?	N/A
N/A	Landing Length (in)	N/A	N/A	DWS Provided?	N/A
N/A	Landing Width (in)	N/A	N/A	DWS Contrast?	N/A
N/A	Landing Slope (%)	N/A	N/A	DWS Length (in)	N/A
N/A	Landing X Slope (%)	N/A	N/A	DWS Full Width?	N/A
N/A	Landing Curb? (Y/N)	N/A	N/A	DWS Offset (in)	N/A
N/A	Shared Landing?	N/A			
N/A	Gutter Ponding?	N/A	N/A	Gutter Slope (%)	N/A
N/A	Gutter Lip Ht (in)	N/A	N/A	Gutter X Slope (%)	N/A
N/A	Painted X Walk1?	No	N/A	Painted X Walk2?	No
	X Walk 1 Direction	To N		X Walk 2 Direction	To W
N/A	X Walk 1 Width (in)	N/A	N/A	X Walk 2 Width (in)	N/A
	X Walk 1 Slope (%)	2.7		X Walk 2 Slope (%)	4.5
	X Walk 1 X Slope (%)	6.6		X Walk 2 X Slope (%)	0.3

N/A	Ramp inside XWalk1?	N/A	N/A	Ramp inside XWalk2?	N/A
	Road Slope (%)	6.0	N/A	Clear Space?	N/A
	Road X Slope (%)	2.8	N/A	Clear Space to XWalk (in)	N/A
N/A	Any Obstructions?	N/A	N/A	Storm Grate/Utility Hazard?	N/A
	Obstruction Type			Storm Grate/Utility Type	
		N/A			N/A
			Yes	Surface Condition? (G/P)	Good

Remove & Replace Curb Ramp With Two New Directional Ramps or Equivalent.
