# Access Compliance Report

## Public Rights-of-Way

### (Curb Ramps)

Intersection ID: 10022037	Main Street: BRYANT_FARMS_RD	Cross Street: N/A	Location: SW
ADA ID: 90C23AA2EE7B	Ramp Type: BlendTrans1	Initial Pass/Fail: Fail	Overall Compliance: No
Severity Score: 8.75			
Codes/Mitigation Info/Possible Solution		Field Measurements/Component Compliance

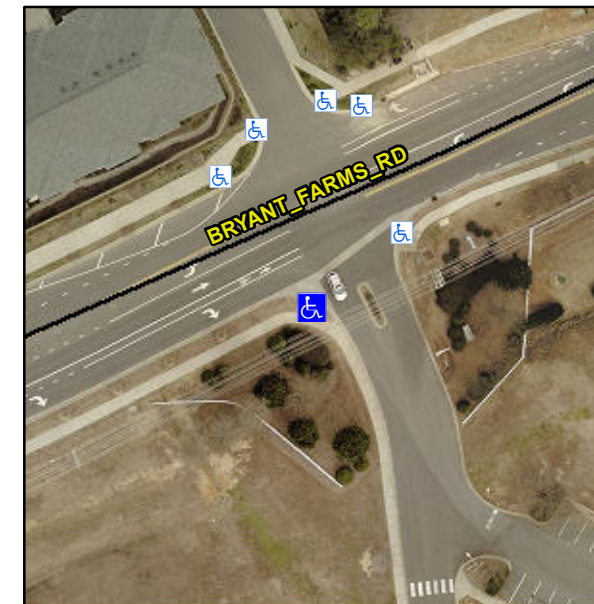
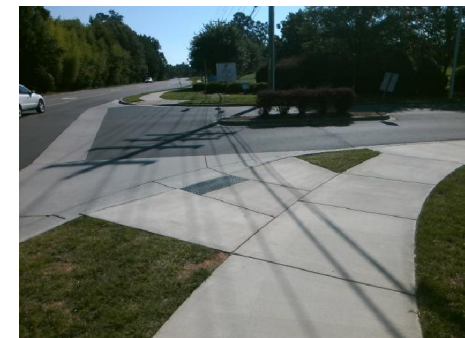
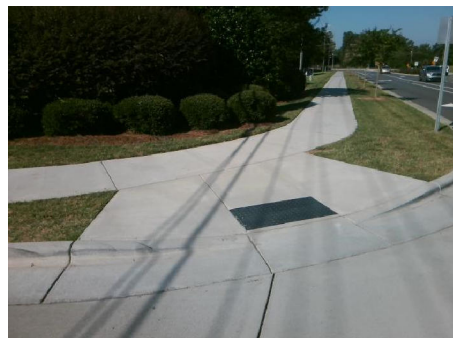
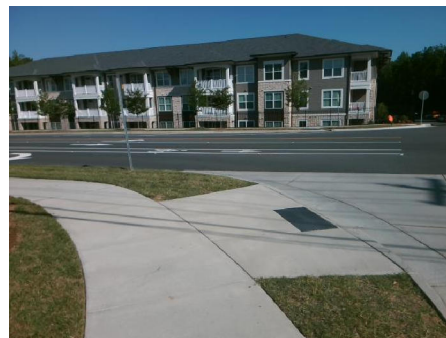
Compliance	Description	Data	Compliance	Description	Data
N/A	Ramp Length (in)	89.0	Yes	BlendTrans Slope (%)	1.1
No	Ramp Width (in)	47.0	Yes	BlendTrans XSlope (%)	0.2
N/A	Flare Type LT	N/A	N/A	Flare Type RT	N/A
N/A	Flare Slope LT (%)	N/A	N/A	Flare Slope RT (%)	N/A
N/A	Flare Traversable LT?	N/A	N/A	Flare Traversable RT?	N/A
N/A	Landing Length (in)	N/A	N/A	DWS Provided?	N/A
N/A	Landing Width (in)	N/A	N/A	DWS Contrast?	N/A
N/A	Landing Slope (%)	N/A	N/A	DWS Length (in)	N/A
N/A	Landing X Slope (%)	N/A	N/A	DWS Full Width?	N/A
N/A	Landing Curb? (Y/N)	N/A	N/A	DWS Offset (in)	N/A
N/A	Shared Landing?	N/A			
N/A	Gutter Ponding?	N/A	N/A	Gutter Slope (%)	N/A
N/A	Gutter Lip Ht (in)	N/A	N/A	Gutter X Slope (%)	N/A
N/A	Painted X Walk1?	No	N/A	Painted X Walk2?	No
	X Walk 1 Direction	To NE		X Walk 2 Direction	To NW
	X Walk 1 Width (in)	N/A		X Walk 2 Width (in)	N/A
	X Walk 1 Slope (%)	0.9		X Walk 2 Slope (%)	0.2
	X Walk 1 X Slope (%)	0.2		X Walk 2 X Slope (%)	2.2

N/A	Ramp inside XWalk1?	N/A	N/A	Ramp inside XWalk2?	N/A
	Road Slope (%)	0.9		Clear Space?	N/A
	Road X Slope (%)	1.9	N/A	Clear Space to XWalk (in)	N/A
N/A	Any Obstructions?	N/A	N/A	Storm Grate/Utility Hazard?	N/A
	Obstruction Type			Storm Grate/Utility Type	
		N/A			N/A
			Yes	Surface Condition? (G/P)	Good
			N/A	Curb Slope (%)	3.0

**Remove & Replace Curb Ramp With Two New Directional Ramps or Equivalent.**

**R304.5.1**

Total Cost: \$ 3200.00
