Access Compliance Report

Public Rights-of-Way

(Curb Ramps)

Intersection ID: 13190	Main Street: W_BLAND_ST	Cross Street: S_CHURCH_ST	Location: E
ADA ID: 90C2B81E1A50	Ramp Type: PerpDiag	Initial Pass/Fail: Fail	Overall Compliance: No
Severity Score: 33.75			
Codes/Mitigation Info/Possible Solution		Field Measurements/Component Compliance

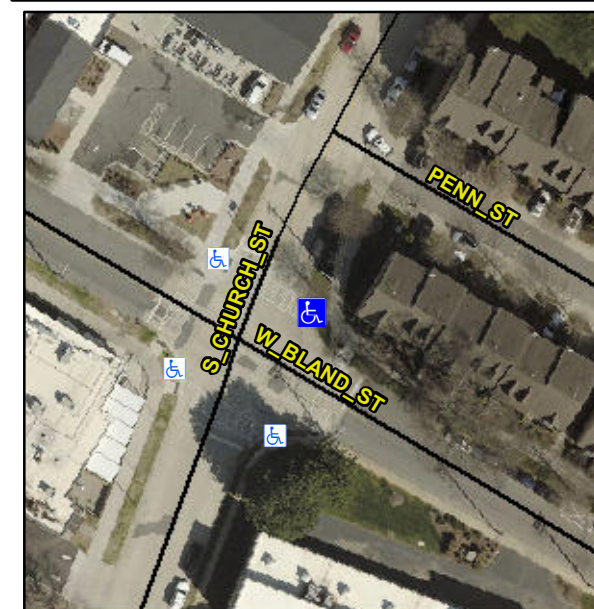
Not Found, R304.5.1, R304.5.3

Compliance	Description	Data	Compliance	Description	Data
N/A	Ramp Length (in)	112.0	Yes	Ramp Slope (%)	6.7
No	Ramp Width (in)	40.0	No	Ramp XSlope (%)	7.2
N/A	Flare Type LT	N/A	N/A	Flare Type RT	N/A
N/A	Flare Slope LT (%)	N/A	N/A	Flare Slope RT (%)	N/A
N/A	Flare Traversable LT?	N/A	N/A	Flare Traversable RT?	N/A
N/A	Landing Length (in)	N/A	N/A	DWS Provided?	N/A
N/A	Landing Width (in)	N/A	N/A	DWS Contrast?	N/A
N/A	Landing Slope (%)	N/A	N/A	DWS Length (in)	N/A
N/A	Landing X Slope (%)	N/A	N/A	DWS Full Width?	N/A
N/A	Landing Curb? (Y/N)	N/A	N/A	DWS Offset (in)	N/A
N/A	Shared Landing?	N/A			
N/A	Gutter Ponding?	N/A	N/A	Gutter Slope (%)	N/A
N/A	Gutter Lip Ht (in)	N/A	N/A	Gutter X Slope (%)	N/A
N/A	Painted X Walk1?	No	N/A	Painted X Walk2?	No
	X Walk 1 Direction	To NW		X Walk 2 Direction	To SW
N/A	X Walk 1 Width (in)	N/A	N/A	X Walk 2 Width (in)	N/A
	X Walk 1 Slope (%)	2.7		X Walk 2 Slope (%)	4.8
	X Walk 1 X Slope (%)	4.3		X Walk 2 X Slope (%)	3.3

N/A	Ramp inside XWalk1?	N/A	N/A	Ramp inside XWalk2?	N/A
	Road Slope (%)	4.8	N/A	Clear Space?	N/A
	Road X Slope (%)	0.8	N/A	Clear Space to XWalk (in)	N/A
N/A	Any Obstructions?	N/A	N/A	Storm Grate/Utility Hazard?	N/A
	Obstruction Type			Storm Grate/Utility Type	
		N/A			N/A
		Yes		Surface Condition? (G/P)	Good

Possible Solutions:

Remove & Replace Curb Ramp With Two New Directional Ramps or Equivalent.
