# Access Compliance Report

## Public Rights-of-Way

### (Curb Ramps)

Intersection ID: 11538	Main Street: FREEDOM_DR	Cross Street: BERRYHILL_RD	Location:	N
ADA ID: 90CFEDCD1922	Ramp Type: Perp	Initial Pass/Fail: Fail	Overall Compliance: No	Severity Score: 21.25
Codes/Mitigation Info/Possible Solution		Field Measurements/Component Compliance

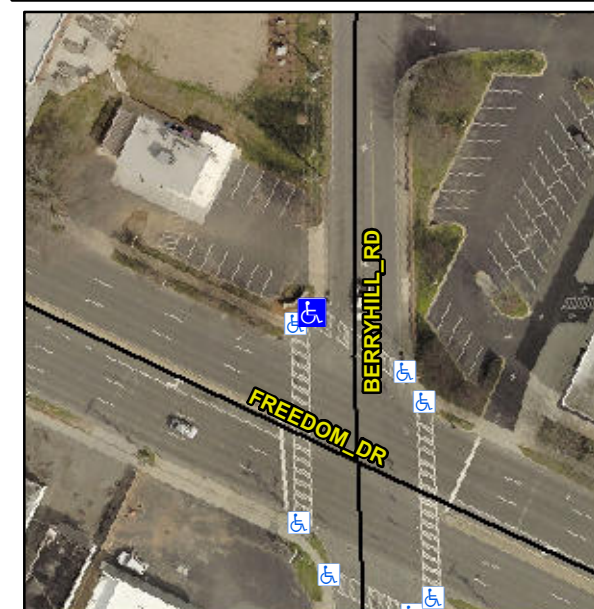
**Not Found, R304.5.1, R304.2.2**

Compliance	Description	Data	Compliance	Description	Data
N/A	Ramp Length (in)	71.5	No	Ramp Slope (%)	11.3
No	Ramp Width (in)	47.0	Yes	Ramp XSlope (%)	0.5
N/A	Flare Type LT	N/A	N/A	Flare Type RT	N/A
N/A	Flare Slope LT (%)	N/A	N/A	Flare Slope RT (%)	N/A
N/A	Flare Traversable LT?	N/A	N/A	Flare Traversable RT?	N/A
N/A	Landing Length (in)	N/A	N/A	DWS Provided?	N/A
N/A	Landing Width (in)	N/A	N/A	DWS Contrast?	N/A
N/A	Landing Slope (%)	N/A	N/A	DWS Length (in)	N/A
N/A	Landing X Slope (%)	N/A	N/A	DWS Full Width?	N/A
N/A	Landing Curb? (Y/N)	N/A	N/A	DWS Offset (in)	N/A
N/A	Shared Landing?	N/A			
N/A	Gutter Ponding?	Yes	N/A	Gutter Slope (%)	N/A
N/A	Gutter Lip Ht (in)	0.5	N/A	Gutter X Slope (%)	N/A
N/A	Painted X Walk1?	Yes	N/A	Painted X Walk2?	N/A
	X Walk 1 Direction	To SE		X Walk 2 Direction	N/A
N/A	X Walk 1 Width (in)	105.0	N/A	X Walk 2 Width (in)	N/A
	X Walk 1 Slope (%)	2.1		X Walk 2 Slope (%)	N/A
	X Walk 1 X Slope (%)	0.6		X Walk 2 X Slope (%)	N/A

N/A	Ramp inside XWalk1?	Yes	N/A	Ramp inside XWalk2?	N/A
	Road Slope (%)	N/A	N/A	Clear Space?	N/A
	Road X Slope (%)	N/A	N/A	Clear Space to XWalk (in)	N/A
N/A	Any Obstructions?	N/A	N/A	Storm Grate/Utility Hazard?	N/A
	Obstruction Type			Storm Grate/Utility Type	
		N/A			N/A
		Yes		Surface Condition? (G/P)	Good

Possible Solutions:

**Remove & Replace Entire Ramp.**
