# Access Compliance Report

## Public Rights-of-Way

### (Curb Ramps)

Intersection ID: 8587	Main Street: HAINES_ST	Cross Street: HATERAS_AV	Location: NE
ADA ID: 90D1C2638D52	Ramp Type: BlendTrans1	Initial Pass/Fail: Fail	Overall Compliance: No
			Severity Score: 21.25

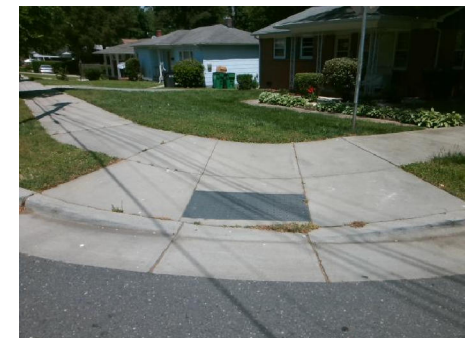
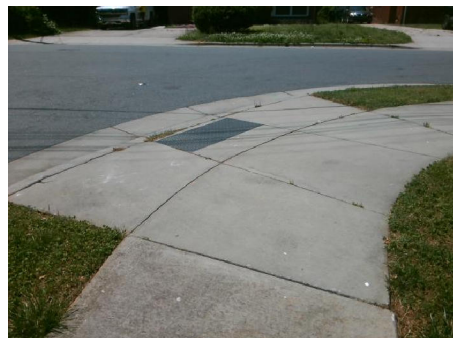
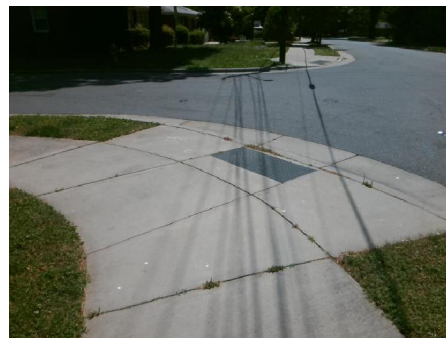
**Not Found, R304.5.1, R304.5.3**

Compliance	Description	Data	Compliance	Description	Data
N/A	Ramp Length (in)	106.0	Yes	BlendTrans Slope (%)	3.4
No	Ramp Width (in)	47.5	No	BlendTrans XSlope (%)	5.4
N/A	Flare Type LT	N/A	N/A	Flare Type RT	N/A
N/A	Flare Slope LT (%)	N/A	N/A	Flare Slope RT (%)	N/A
N/A	Flare Traversable LT?	N/A	N/A	Flare Traversable RT?	N/A
N/A	Landing Length (in)	N/A	N/A	DWS Provided?	N/A
N/A	Landing Width (in)	N/A	N/A	DWS Contrast?	N/A
N/A	Landing Slope (%)	N/A	N/A	DWS Length (in)	N/A
N/A	Landing X Slope (%)	N/A	N/A	DWS Full Width?	N/A
N/A	Landing Curb? (Y/N)	N/A	N/A	DWS Offset (in)	N/A
N/A	Shared Landing?	N/A			
N/A	Gutter Ponding?	N/A	N/A	Gutter Slope (%)	N/A
N/A	Gutter Lip Ht (in)	N/A	N/A	Gutter X Slope (%)	N/A
N/A	Painted X Walk1?	No	N/A	Painted X Walk2?	N/A
	X Walk 1 Direction	To S		X Walk 2 Direction	N/A
	X Walk 1 Width (in)	N/A		X Walk 2 Width (in)	N/A
	X Walk 1 Slope (%)	0.8		X Walk 2 Slope (%)	N/A
	X Walk 1 X Slope (%)	2.9		X Walk 2 X Slope (%)	N/A

N/A	Ramp inside XWalk1?	N/A	N/A	Ramp inside XWalk2?	N/A
	Road Slope (%)	2.9		Clear Space?	N/A
	Road X Slope (%)	0.8	N/A	Clear Space to XWalk (in)	N/A
N/A	Any Obstructions?	N/A	N/A	Storm Grate/Utility Hazard?	N/A
	Obstruction Type			Storm Grate/Utility Type	
		N/A			N/A
			Yes	Surface Condition? (G/P)	Good
			No	Curb Slope (%)	15.6

**Remove & Replace Curb Ramp With Two New Directional Ramps or Equivalent.**
