# Access Compliance Report

## Public Rights-of-Way

| Intersection ID: 47087 | Main Street: MARVIN_RD | Cross Street: COVENTRY_COURT_LN | Location: SW |
| ADA ID: 90D3D0BE178C | Ramp Type: Perp | Initial Pass/Fail: Pass | Overall Compliance: No |

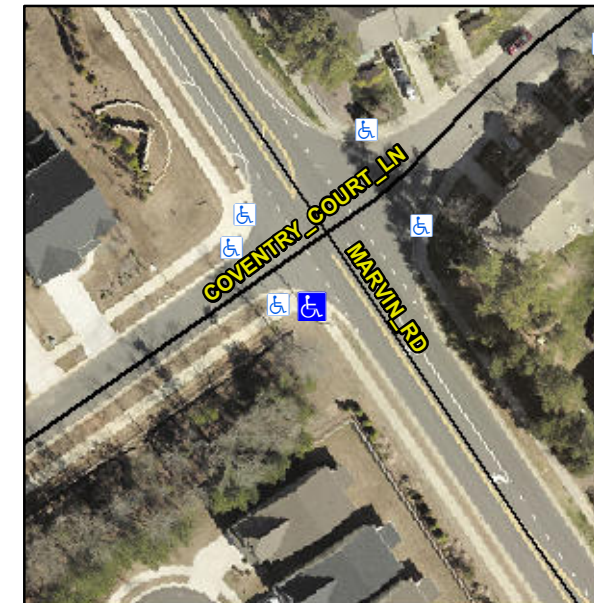
**R304.2.1, R304.2.2-Perp, R304.3.2-Para, R304.5.3, R304.5.4**

| Compliance | Description | Data | Compliance | Description | Data |
|---|---|---|---|---|---|
| No | Landing Length (in) | N/A | Yes | DWS Provided? | Yes |
| No | Landing Width (in) | N/A | Yes | DWS Contrast? | Yes |
| No | Landing Slope (%) | N/A | Yes | DWS Length (in) | 24.0 |
| No | Landing X Slope (%) | N/A | Yes | DWS Full Width? | Yes |
| Yes | Gutter Ponding? | No | No | Gutter Slope (%) | 5.8 |

**Install Landing. Remove & Replace Gutter.**
