# Access Compliance Report

## Public Rights-of-Way

### (Curb Ramps)

Intersection ID: 10011612	Main Street: UNIVERSITY_CITY_BV	Cross Street: N/A	Location: S
ADA ID: 90E0F038DA56	Ramp Type: Perp	Initial Pass/Fail: Fail	Overall Compliance: No
Severity Score: 8.75			
Codes/Mitigation Info/Possible Solution		Field Measurements/Component Compliance

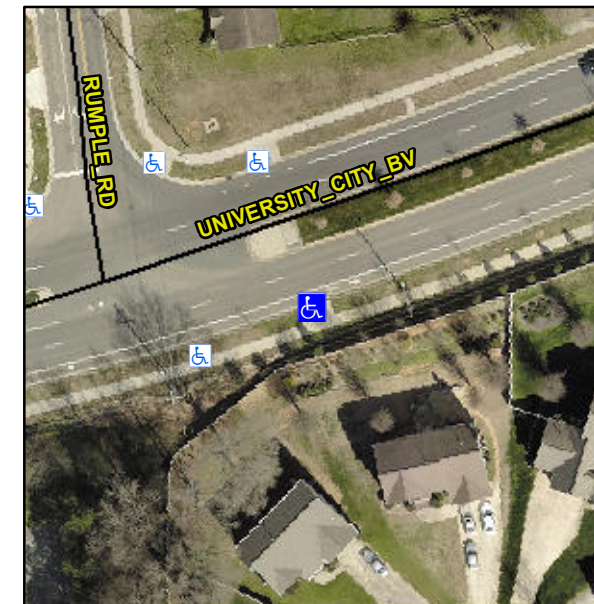
**Not Found, R304.5.1**

Compliance	Description	Data	Compliance	Description	Data
N/A	Ramp Length (in)	96.0	Yes	Ramp Slope (%)	7.6
No	Ramp Width (in)	47.0	Yes	Ramp XSlope (%)	0.8
N/A	Flare Type LT	N/A	N/A	Flare Type RT	N/A
N/A	Flare Slope LT (%)	N/A	N/A	Flare Slope RT (%)	N/A
N/A	Flare Traversable LT?	N/A	N/A	Flare Traversable RT?	N/A
N/A	Landing Length (in)	N/A	N/A	DWS Provided?	N/A
N/A	Landing Width (in)	N/A	N/A	DWS Contrast?	N/A
N/A	Landing Slope (%)	N/A	N/A	DWS Length (in)	N/A
N/A	Landing X Slope (%)	N/A	N/A	DWS Full Width?	N/A
N/A	Landing Curb? (Y/N)	N/A	N/A	DWS Offset (in)	N/A
N/A	Shared Landing?	N/A			
N/A	Gutter Ponding?	N/A	N/A	Gutter Slope (%)	N/A
N/A	Gutter Lip Ht (in)	N/A	N/A	Gutter X Slope (%)	N/A
N/A	Painted X Walk1?	No	N/A	Painted X Walk2?	N/A
	X Walk 1 Direction	To N		X Walk 2 Direction	N/A
N/A	X Walk 1 Width (in)	N/A	N/A	X Walk 2 Width (in)	N/A
	X Walk 1 Slope (%)	2.7		X Walk 2 Slope (%)	N/A
	X Walk 1 X Slope (%)	0.8		X Walk 2 X Slope (%)	N/A

N/A	Ramp inside XWalk1?	N/A	N/A	Ramp inside XWalk2?	N/A
	Road Slope (%)	N/A	N/A	Clear Space?	N/A
	Road X Slope (%)	N/A	N/A	Clear Space to XWalk (in)	N/A
N/A	Any Obstructions?	N/A	N/A	Storm Grate/Utility Hazard?	N/A
	Obstruction Type			Storm Grate/Utility Type	
		N/A			N/A
			Yes	Surface Condition? (G/P)	Good

**Remove & Replace Entire Ramp.**
