Access Compliance Report Public Rights-of-Way (Curb Ramps)

Intersection ID: 52999 Main Street: VICTORIA_BROOK_LN Cross Street: GRANT_MARTIN_DR Location: N

ADA ID: 90E378A5814D Ramp Type: PerpDiag Initial Pass/Fail: Fail Overall Compliance: No Severity Score: 12.5

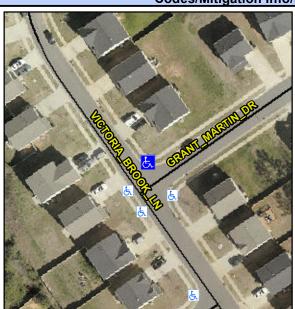
Not Found, R304.5.3

Compliance Description		Data	Compliance Description		Data
N	A Ramp Length (in)	47.5	Yes	Ramp Slope (%)	5.3
Ye	es Ramp Width (in)	48.0	No	Ramp XSlope (%)	5.1
N	A Flare Type LT	N/A	N/A	Flare Type RT	N/A
N	A Flare Slope LT (%)	N/A	N/A	Flare Slope RT (%)	N/A
N	A Flare Traversable LT?	N/A	N/A	Flare Traversable RT?	N/A
N	A Landing Length (in)	N/A	N/A	DWS Provided?	N/A
N	A Landing Width (in)	N/A	N/A	DWS Contrast?	N/A
N	A Landing Slope (%)	N/A	N/A	DWS Length (in)	N/A
N	A Landing X Slope (%)	N/A	N/A	DWS Full Width?	N/A
N	A Landing Curb? (Y/N)	N/A	N/A	DWS Offset (in)	N/A
N	A Shared Landing?	N/A			
N	A Gutter Ponding?	N/A	N/A	Gutter Slope (%)	N/A
N/	A Gutter Lip Ht (in)	N/A	N/A	Gutter X Slope (%)	N/A
N	A Painted X Walk1?	No	N/A	Painted X Walk2?	No
	X Walk 1 Direction	To SW		X Walk 2 Direction	To SW
N	A X Walk 1 Width (in)	N/A	N/A	X Walk 2 Width (in)	N/A
	X Walk 1 Slope (%)	4.4		X Walk 2 Slope (%)	3.3
	X Walk 1 X Slope (%)	4.3		X Walk 2 X Slope (%)	2.3

N	A Ramp inside XWalk1?	N/A	N/A	Ramp inside XWalk2?	N/A
	Road Slope (%)	2.8	N/A	Clear Space?	N/A
	Road X Slope (%)	1.3	N/A	Clear Space to XWalk (in)	N/A
N	Any Obstructions?	N/A	N/A	Storm Grate/Utility Hazard?	N/A
	Obstruction Type			Storm Grate/Utility Type	
		N/A			N/A

Remove & Replace Curb Ramp With Two New Directional Ramps or Equivalent.

Total Cost: \$ 3200.00
