# Access Compliance Report

## Public Rights-of-Way

### (Curb Ramps)

Intersection ID: 4861	Main Street: HEDGECREST_PL	Cross Street: MOSSY_BANK_PL	Location: SE
ADA ID: 90E90FBB6C49	Ramp Type: Perp	Initial Pass/Fail: Fail	Overall Compliance: No
Severity Score: 8.75			
Codes/Mitigation Info/Possible Solution		Field Measurements/Component Compliance

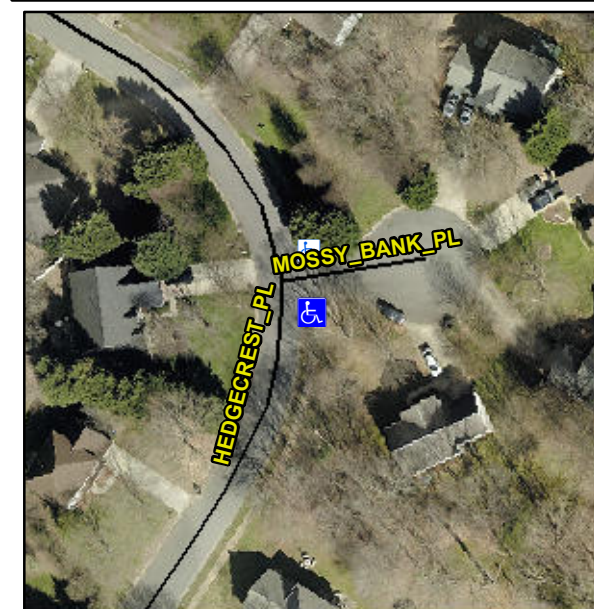
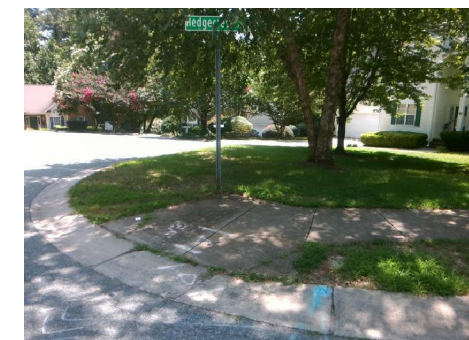
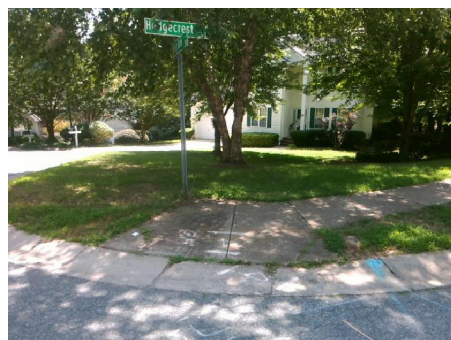
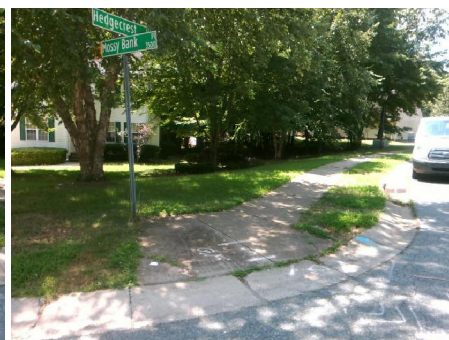
Compliance	Description	Data	Compliance	Description	Data
N/A	Ramp Length (in)	36.0	Yes	Ramp Slope (%)	6.4
No	Ramp Width (in)	43.0	Yes	Ramp XSlope (%)	1.7
N/A	Flare Type LT	N/A	N/A	Flare Type RT	N/A
N/A	Flare Slope LT (%)	N/A	N/A	Flare Slope RT (%)	N/A
N/A	Flare Traversable LT?	N/A	N/A	Flare Traversable RT?	N/A
N/A	Landing Length (in)	N/A	N/A	DWS Provided?	N/A
N/A	Landing Width (in)	N/A	N/A	DWS Contrast?	N/A
N/A	Landing Slope (%)	N/A	N/A	DWS Length (in)	N/A
N/A	Landing X Slope (%)	N/A	N/A	DWS Full Width?	N/A
N/A	Landing Curb? (Y/N)	N/A	N/A	DWS Offset (in)	N/A
N/A	Shared Landing?	N/A			
N/A	Gutter Ponding?	N/A	N/A	Gutter Slope (%)	N/A
N/A	Gutter Lip Ht (in)	N/A	N/A	Gutter X Slope (%)	N/A
N/A	Painted X Walk1?	No	N/A	Painted X Walk2?	N/A
	X Walk 1 Direction	To N		X Walk 2 Direction	N/A
N/A	X Walk 1 Width (in)	N/A	N/A	X Walk 2 Width (in)	N/A
	X Walk 1 Slope (%)	4.0		X Walk 2 Slope (%)	N/A
	X Walk 1 X Slope (%)	5.1		X Walk 2 X Slope (%)	N/A

N/A	Ramp inside XWalk1?	N/A	N/A	Ramp inside XWalk2?	N/A
	Road Slope (%)	N/A	N/A	Clear Space?	N/A
	Road X Slope (%)	N/A	N/A	Clear Space to XWalk (in)	N/A
N/A	Any Obstructions?	N/A	N/A	Storm Grate/Utility Hazard?	N/A
	Obstruction Type			Storm Grate/Utility Type	
		N/A			N/A
			Yes	Surface Condition? (G/P)	Good

**Remove & Replace Entire Ramp.**

**R304.5.1**

**\$ 1850.00**
