Access Compliance Report

Public Rights-of-Way

(Curb Ramps)

Intersection ID: 51054	Main Street: MULBERRY_CHURCH_RD	Cross Street: N/A	Location: SW
ADA ID: 90FC51242E87	Ramp Type: BlendTrans1	Initial Pass/Fail: Fail	Overall Compliance: No
Codes/Mitigation Info/Possible Solution		Field Measurements/Component Compliance	
		Severity Score: 10

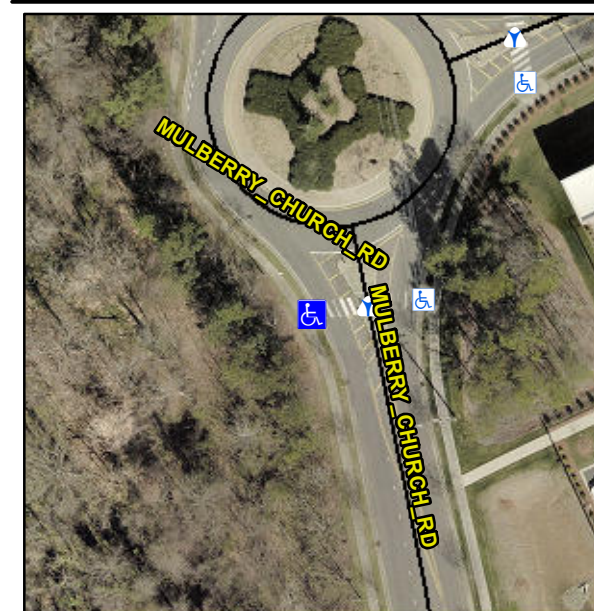
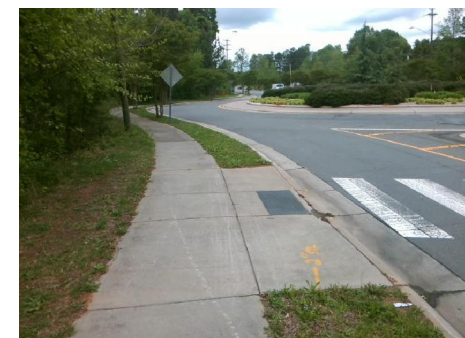
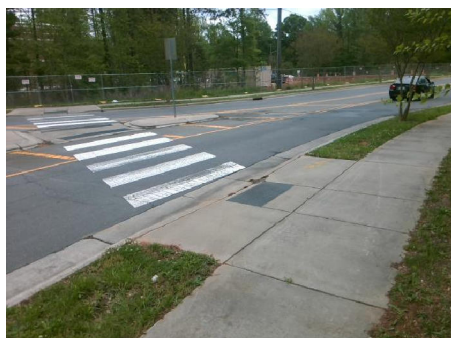
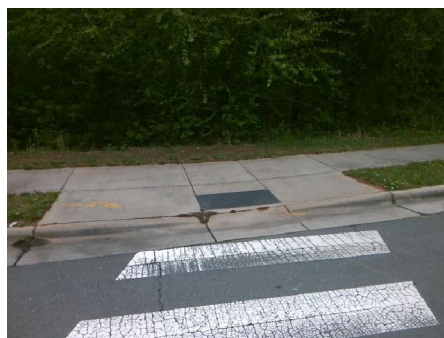
Not Found, R304.5.1, R304.5.3

Compliance	Description	Data	Compliance	Description	Data
N/A	Ramp Length (in)	48.0	Yes	BlendTrans Slope (%)	3.2
No	Ramp Width (in)	47.0	No	BlendTrans XSlope (%)	2.6
N/A	Flare Type LT	N/A	N/A	Flare Type RT	N/A
N/A	Flare Slope LT (%)	N/A	N/A	Flare Slope RT (%)	N/A
N/A	Flare Traversable LT?	N/A	N/A	Flare Traversable RT?	N/A
N/A	Landing Length (in)	N/A	N/A	DWS Provided?	N/A
N/A	Landing Width (in)	N/A	N/A	DWS Contrast?	N/A
N/A	Landing Slope (%)	N/A	N/A	DWS Length (in)	N/A
N/A	Landing X Slope (%)	N/A	N/A	DWS Full Width?	N/A
N/A	Landing Curb? (Y/N)	N/A	N/A	DWS Offset (in)	N/A
N/A	Shared Landing?	N/A			
N/A	Gutter Ponding?	N/A	N/A	Gutter Slope (%)	N/A
N/A	Gutter Lip Ht (in)	N/A	N/A	Gutter X Slope (%)	N/A
N/A	Painted X Walk1?	Yes	N/A	Painted X Walk2?	N/A
	X Walk 1 Direction	To E		X Walk 2 Direction	N/A
	X Walk 1 Width (in)	116.0		X Walk 2 Width (in)	N/A
	X Walk 1 Slope (%)	1.9		X Walk 2 Slope (%)	N/A
	X Walk 1 X Slope (%)	1.3		X Walk 2 X Slope (%)	N/A

N/A	Ramp inside XWalk1?	Yes	N/A	Ramp inside XWalk2?	N/A
	Road Slope (%)	1.3		Clear Space?	N/A
	Road X Slope (%)	1.9	N/A	Clear Space to XWalk (in)	N/A
N/A	Any Obstructions?	N/A	N/A	Storm Grate/Utility Hazard?	N/A
	Obstruction Type			Storm Grate/Utility Type	
		N/A			N/A
			Yes	Surface Condition? (G/P)	Good
			No	Curb Slope (%)	17.0

Remove & Replace Curb Ramp With Two New Directional Ramps or Equivalent.
