# Access Compliance Report

## Public Rights-of-Way

### (Curb Ramps)

Intersection ID: 8368	Main Street: HONDURES_DR	Cross Street: W_SUGAR_CREEK_RD	Location: SW
ADA ID: 9106B9854A64	Ramp Type: ParaDiag	Initial Pass/Fail: Fail	Overall Compliance: No
Codes/Mitigation Info/Possible Solution		Field Measurements/Component Compliance	
Severity Score: 48.75

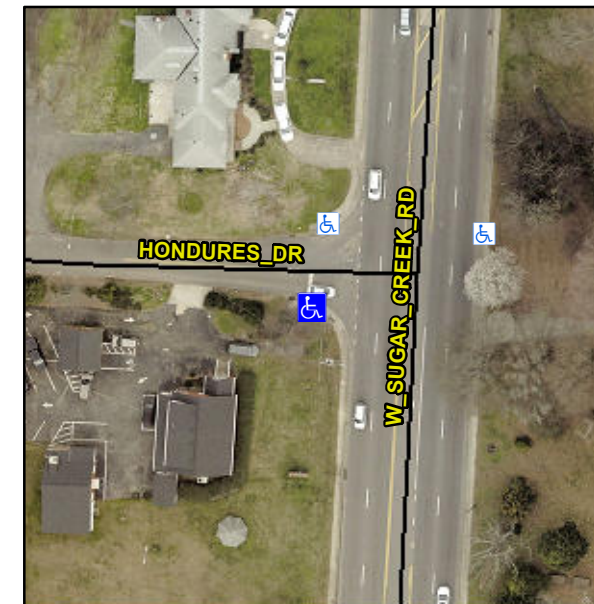
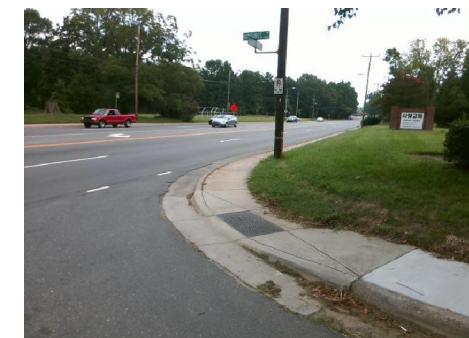
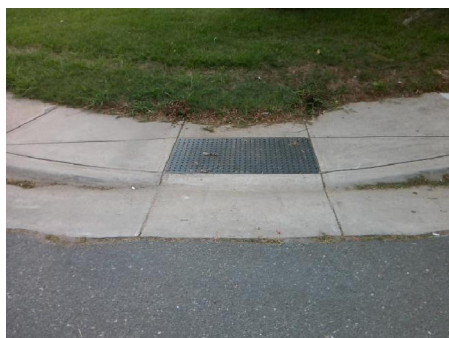
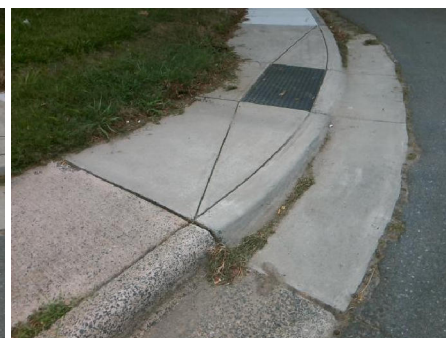
**LT RP < 5%**

**R304.5.1, R304.5.3, R304.3.2**

Compliance	Description	Data	Compliance	Description	Data
N/A	Ramp Length LT (in)	56.0	N/A	Ramp Length RT (in)	59.0
No	Ramp Width LT (in)	26.0	No	Ramp Width RT (in)	32.0
Yes	Ramp Slope LT (%)	1.6	No	Ramp Slope RT (%)	11.7
No	Ramp XSlope LT (%)	2.8	Yes	Ramp XSlope RT (%)	1.6
N/A	Landing Length (in)	N/A	N/A	DWS Provided?	N/A
N/A	Landing Width (in)	N/A	N/A	DWS Contrast?	N/A
N/A	Landing Slope (%)	N/A	N/A	DWS Length (in)	N/A
N/A	Landing X Slope (%)	N/A	N/A	DWS Full Width?	N/A
N/A	Landing Curb? (Y/N)	N/A	N/A	DWS Offset (in)	N/A
N/A	Shared Landing?	N/A			
N/A	Gutter Ponding?	N/A	N/A	Gutter Slope (%)	N/A
N/A	Gutter Lip Ht (in)	N/A	N/A	Gutter X Slope (%)	N/A
N/A	Painted X Walk1?	No	N/A	Painted X Walk2?	No
	X Walk 1 Direction	To E		X Walk 2 Direction	To N
N/A	X Walk 1 Width (in)	N/A	N/A	X Walk 2 Width (in)	N/A
	X Walk 1 Slope (%)	1.1		X Walk 2 Slope (%)	2.3
	X Walk 1 X Slope (%)	2.2		X Walk 2 X Slope (%)	2.5
N/A	Ramp inside XWalk1?	N/A	N/A	Ramp inside XWalk2?	N/A

Road Slope (%)	3.8	N/A	Clear Space?	N/A
	Road X Slope (%)	1.4	N/A	Clear Space to XWalk (in)	N/A
N/A	Any Obstructions?	N/A	N/A	Storm Grate/Utility Hazard?	N/A
	Obstruction Type			Storm Grate/Utility Type	
		N/A			N/A
			Yes	Surface Condition? (G/P)	Good
			N/A	Curb Slope (%)	23.6

**Remove & Replace Curb Ramp With Two New Directional Ramps or Equivalent.**
