Access Compliance Report

Public Rights-of-Way

(Curb Ramps)

Intersection ID: 10030167	Main Street: LATROBE_DR	Cross Street: N/A	Location: E
ADA ID: 911690CD9625	Ramp Type: PerpDiag	Initial Pass/Fail: Fail	Overall Compliance: No
Codes/Mitigation Info/Possible Solution		Field Measurements/Component Compliance	
Severity Score: 21.25

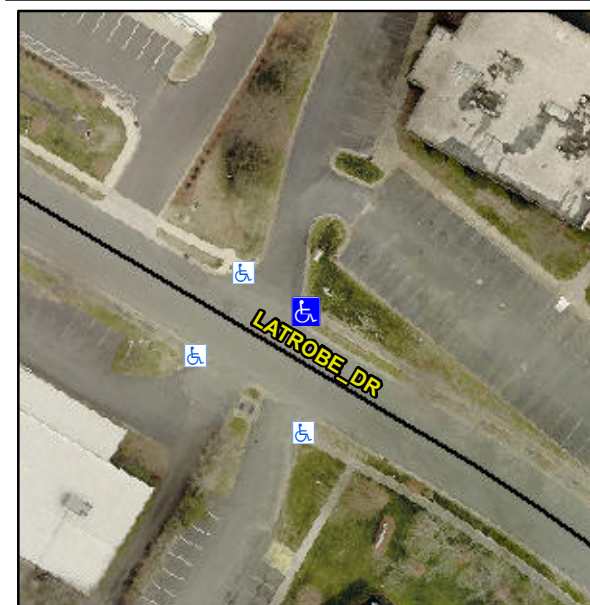
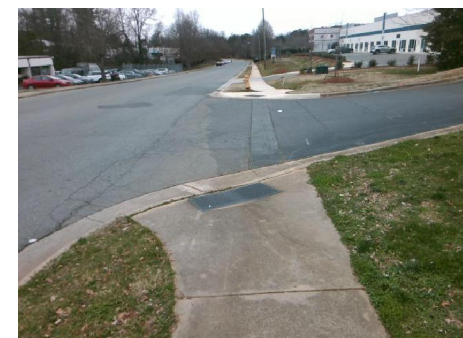
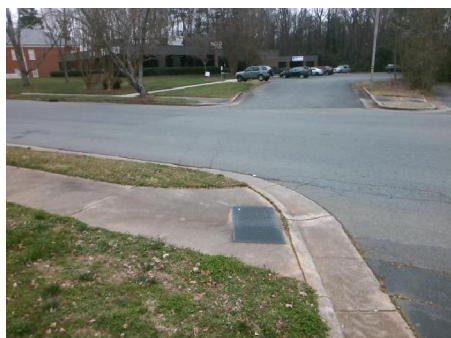
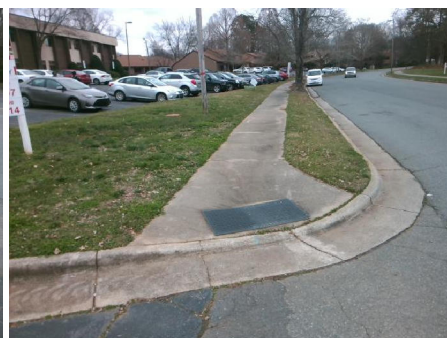
Not Found, R304.5.1, R304.5.3

Compliance	Description	Data	Compliance	Description	Data
N/A	Ramp Length (in)	48.0	Yes	Ramp Slope (%)	7.6
No	Ramp Width (in)	36.0	No	Ramp XSlope (%)	5.3
N/A	Flare Type LT	N/A	N/A	Flare Type RT	N/A
N/A	Flare Slope LT (%)	N/A	N/A	Flare Slope RT (%)	N/A
N/A	Flare Traversable LT?	N/A	N/A	Flare Traversable RT?	N/A
N/A	Landing Length (in)	N/A	N/A	DWS Provided?	N/A
N/A	Landing Width (in)	N/A	N/A	DWS Contrast?	N/A
N/A	Landing Slope (%)	N/A	N/A	DWS Length (in)	N/A
N/A	Landing X Slope (%)	N/A	N/A	DWS Full Width?	N/A
N/A	Landing Curb? (Y/N)	N/A	N/A	DWS Offset (in)	N/A
N/A	Shared Landing?	N/A			
N/A	Gutter Ponding?	N/A	N/A	Gutter Slope (%)	N/A
N/A	Gutter Lip Ht (in)	N/A	N/A	Gutter X Slope (%)	N/A
N/A	Painted X Walk1?	No	N/A	Painted X Walk2?	No
	X Walk 1 Direction	To NW		X Walk 2 Direction	To SW
N/A	X Walk 1 Width (in)	N/A	N/A	X Walk 2 Width (in)	N/A
	X Walk 1 Slope (%)	0.2		X Walk 2 Slope (%)	1.1
	X Walk 1 X Slope (%)	7.1		X Walk 2 X Slope (%)	1.5

N/A	Ramp inside XWalk1?	N/A	N/A	Ramp inside XWalk2?	N/A
	Road Slope (%)	0.9	N/A	Clear Space?	N/A
	Road X Slope (%)	2.4	N/A	Clear Space to XWalk (in)	N/A
N/A	Any Obstructions?	N/A	N/A	Storm Grate/Utility Hazard?	N/A
	Obstruction Type			Storm Grate/Utility Type	
		N/A			N/A
			Yes	Surface Condition? (G/P)	Good

Possible Solutions:

Remove & Replace Curb Ramp With Two New Directional Ramps or Equivalent.
