Access Compliance Report

Public Rights-of-Way

(Curb Ramps)

Intersection ID: 8458	Main Street: BRADFORD_DR	Cross Street: GUM_ST	Location:	S
ADA ID: 911842D49316	Ramp Type: Directional1	Initial Pass/Fail: Fail	Overall Compliance: No	Severity Score: 25
Codes/Mitigation Info/Possible Solution		Field Measurements/Component Compliance

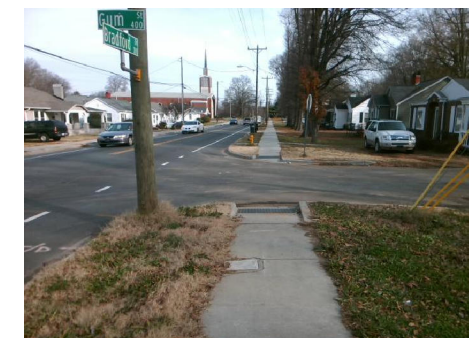
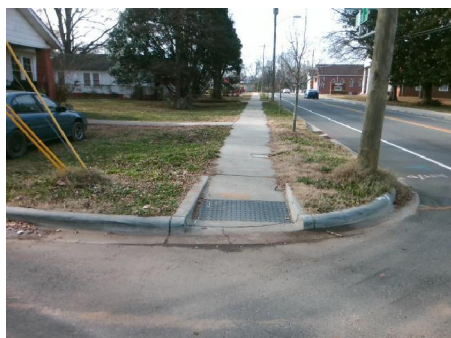
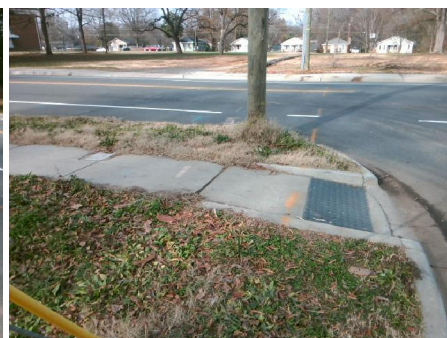
Compliance	Description	Data	Compliance	Description	Data
N/A	Ramp Length (in)	63.0	N/A	Grade Break?	N/A
Yes	Ramp Width (in)	49.0	N/A	Grade Break Slope (%)	0.0
No	Ramp Slope (%)	12.7	N/A	Grade Break XSlope (%)	0.0
Yes	Ramp XSlope (%)	0.1			
N/A	Flare Type LT	N/A	N/A	Flare Type RT	N/A
N/A	Flare Slope LT (%)	N/A	N/A	Flare Slope RT (%)	0.0
N/A	Flare Traversable LT?	N/A	N/A	Flare Traversable RT?	N/A
N/A	Landing Length (in)	0.0	N/A	DWS Provided?	N/A
N/A	Landing Width (in)	0.0	N/A	DWS Contrast?	N/A
N/A	Landing Slope (%)	0.0	N/A	DWS Length (in)	N/A
N/A	Landing X Slope (%)	0.0	N/A	DWS Full Width?	N/A
N/A	Landing Curb? (Y/N)	N/A	N/A	DWS Offset LT (in)	N/A
N/A	Shared Landing?	N/A	N/A	DWS Offset RT (in)	N/A
N/A	Gutter Ponding?	0.0	N/A	Gutter Slope (%)	N/A
N/A	Gutter Lip Ht (in)	0.0	N/A	Gutter X Slope (%)	N/A
N/A	Painted X Walk1?	No		Road Slope (%)	0.9
	X Walk 1 Direction	To NE		Road X Slope (%)	0.5
	X Walk 1 Width (in)	N/A		Clear Space?	N/A

X Walk 1 Slope (%)	0.9	N/A	Clear Space to XWalk (in)	N/A
	X Walk 1 X Slope (%)	0.5	N/A	Storm Grate/Utility Hazard?	N/A
N/A	Ramp inside XWalk1?	N/A		Storm Grate/Utility Type	
N/A	Any Obstructions?	N/A			N/A
	Obstruction Type		Yes	Surface Condition? (G/P)	Good
			N/A	Curb Slope (%)	12.2

Remove & Replace Entire Ramp.
