Access Compliance Report

Public Rights-of-Way

(Curb Ramps)

Intersection ID: N/A	Main Street: TREESIDE_LN	Cross Street: MARGARET_WALLACE_RD	Location: E
ADA ID: 911D7588E890	Ramp Type: BlendTrans2	Initial Pass/Fail: Fail	Overall Compliance: No
			Severity Score: 21.25

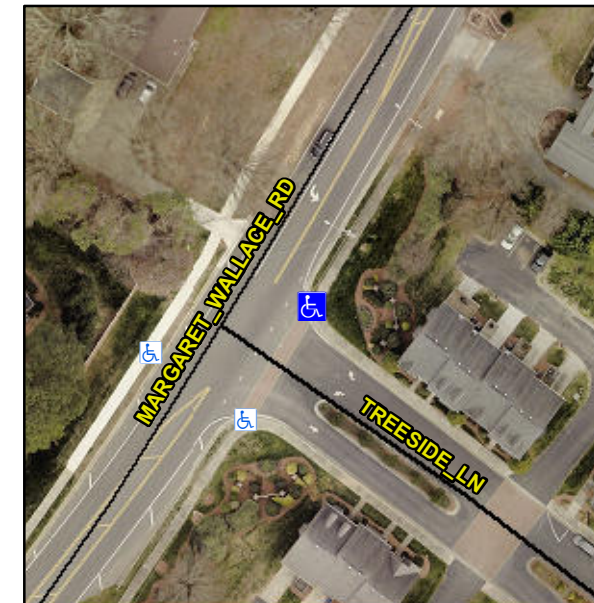
Not Found, R304.5.1, R304.5.3

Compliance	Description	Data	Compliance	Description	Data
N/A	Ramp Length (in)	82.0	Yes	BlendTrans Slope (%)	4.0
No	Ramp Width (in)	41.0	No	BlendTrans XSlope (%)	5.2
N/A	Flare Type LT	N/A	N/A	Flare Type RT	N/A
N/A	Flare Slope LT (%)	N/A	N/A	Flare Slope RT (%)	N/A
N/A	Flare Traversable LT?	N/A	N/A	Flare Traversable RT?	N/A
N/A	Landing Length (in)	N/A	N/A	DWS Provided?	N/A
N/A	Landing Width (in)	N/A	N/A	DWS Contrast?	N/A
N/A	Landing Slope (%)	N/A	N/A	DWS Length (in)	N/A
N/A	Landing X Slope (%)	N/A	N/A	DWS Full Width?	N/A
N/A	Landing Curb? (Y/N)	N/A	N/A	DWS Offset (in)	N/A
N/A	Shared Landing?	N/A			
N/A	Gutter Ponding?	N/A	N/A	Gutter Slope (%)	N/A
N/A	Gutter Lip Ht (in)	N/A	N/A	Gutter X Slope (%)	N/A
N/A	Painted X Walk1?	No	N/A	Painted X Walk2?	No
	X Walk 1 Direction	To NW		X Walk 2 Direction	To SW
	X Walk 1 Width (in)	N/A		X Walk 2 Width (in)	N/A
	X Walk 1 Slope (%)	4.0		X Walk 2 Slope (%)	2.1
	X Walk 1 X Slope (%)	1.1		X Walk 2 X Slope (%)	4.9

N/A	Ramp inside XWalk1?	N/A	N/A	Ramp inside XWalk2?	N/A
	Road Slope (%)	1.0		Clear Space?	N/A
	Road X Slope (%)	2.8	N/A	Clear Space to XWalk (in)	N/A
N/A	Any Obstructions?	N/A	N/A	Storm Grate/Utility Hazard?	N/A
	Obstruction Type			Storm Grate/Utility Type	
		N/A			N/A
			Yes	Surface Condition? (G/P)	Good
			No	Curb Slope (%)	15.3

Remove & Replace Curb Ramp With Two New Directional Ramps or Equivalent.
