## Access Compliance Report Public Rights-of-Way (Curb Ramps)

Intersection ID: 48474 Main Street: AUTUMN\_OAK\_DR Cross Street: WONDERING\_OAK\_LN Location: NE
ADA ID: 9123FEA3E121 Ramp Type: PerpDiag Initial Pass/Fail: Fail Overall Compliance: No Severity Score: 33.75

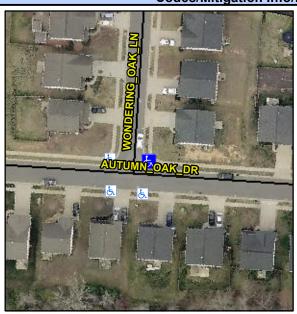
Field Measure	ments/C	ompoi	nent Compliance	
Comp	Compliance Description		Compliance Description		Data
N/A	Ramp Length (in)	47.0	No	Ramp Slope (%)	15.9
No	Ramp Width (in)	46.5	Yes	Ramp XSlope (%)	1.7
N/A	Flare Type LT	N/A	N/A	Flare Type RT	N/A
N/A	Flare Slope LT (%)	N/A	N/A	Flare Slope RT (%)	N/A
N/A	Flare Traversable LT?	N/A	N/A	Flare Traversable RT?	N/A
N/A	Landing Length (in)	N/A	N/A	DWS Provided?	N/A
N/A	Landing Width (in)	N/A	N/A	DWS Contrast?	N/A
N/A	Landing Slope (%)	N/A	N/A	DWS Length (in)	N/A
N/A	Landing X Slope (%)	N/A	N/A	DWS Full Width?	N/A
N/A	Landing Curb? (Y/N)	N/A	N/A	DWS Offset (in)	N/A
N/A	Shared Landing?	N/A			
N/A	Gutter Ponding?	N/A	N/A	Gutter Slope (%)	N/A
N/A	Gutter Lip Ht (in)	N/A	N/A	Gutter X Slope (%)	N/A
N/A	Painted X Walk1?	No	N/A	Painted X Walk2?	No
	X Walk 1 Direction	To W		X Walk 2 Direction	To S
N/A	X Walk 1 Width (in)	N/A	N/A	X Walk 2 Width (in)	N/A
	X Walk 1 Slope (%)	1.9		X Walk 2 Slope (%)	0.5

X Walk 1 X Slope (%)	1.2		X Walk 2 X Slope (%)	1.4
N/A	Ramp inside XWalk1?	N/A	N/A	Ramp inside XWalk2?	N/A
	Road Slope (%)	1.9	N/A	Clear Space?	N/A
	Road X Slope (%)	0.2	N/A	Clear Space to XWalk (in)	N/A
N/A	Any Obstructions?	N/A	N/A	Storm Grate/Utility Hazard?	N/A
	Obstruction Type			Storm Grate/Utility Type	
		N/A			N/A
			Yes	Surface Condition? (G/P)	Good

Possible Solutions:

Remove & Replace Curb Ramp With Two New Directional Ramps or Equivalent.

Not Found, R304.5.1, R304.2.2
