# Access Compliance Report

## Public Rights-of-Way

### (Curb Ramps)

Intersection ID: 29206	Main Street: COULOAK_DR	Cross Street: SEASON GROVE_LN	Location: NW
ADA ID: 91248801D1EA	Ramp Type: PerpDiag	Initial Pass/Fail: Fail	Overall Compliance: No
			Severity Score: 48.75

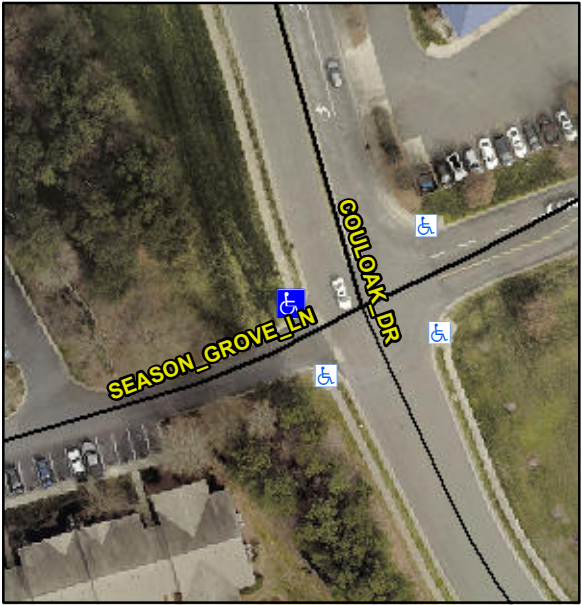
Possible Solutions:				
	<b>Remove &amp; Replace Curb Ramp With Two New Directional Ramps or Equivalent.</b>				
	Surveyor Notes:				
	<b>N/A</b>				
	PROW/ADA:				
	<b>Not Found, R304.5.1, R304.2.2, R304.5.3</b>				
	Street 1 Name	SEASON GROVE LN			
	Stop Condition-Street 2	StopSign			
	Street 2 Name	COULOAK DR			
	Stop Condition-Street 1	None			
	Total Cost:	\$ 3200.00			
Compliance	Description	Data	Compliance	Description	Data
N/A	Ramp Length (in)	82.0	No	Ramp Slope (%)	9.5
No	Ramp Width (in)	24.0	No	Ramp XSlope (%)	2.7
N/A	Flare Type LT	N/A	N/A	Flare Type RT	N/A
N/A	Flare Slope LT (%)	N/A	N/A	Flare Slope RT (%)	N/A
N/A	Flare Traversable LT?	N/A	N/A	Flare Traversable RT?	N/A
N/A	Landing Length (in)	N/A	N/A	DWS Provided?	N/A
N/A	Landing Width (in)	N/A	N/A	DWS Contrast?	N/A
N/A	Landing Slope (%)	N/A	N/A	DWS Length (in)	N/A

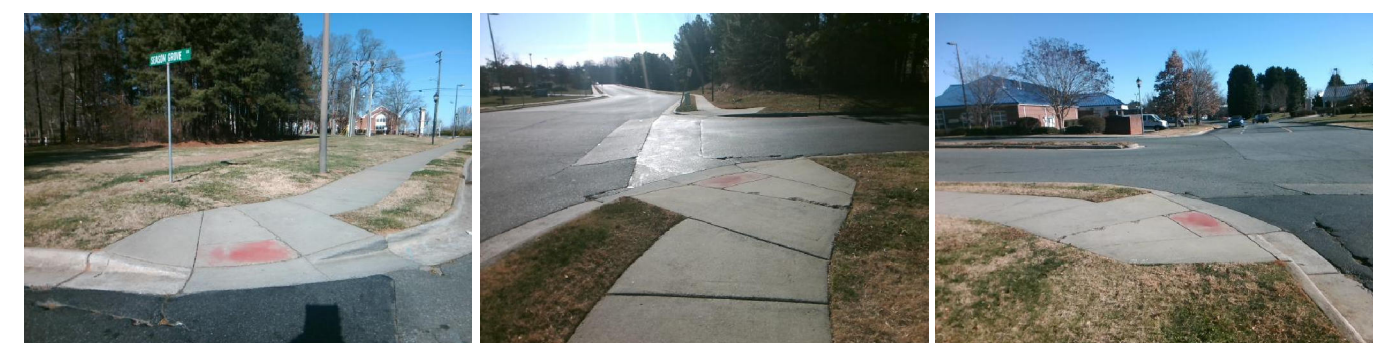
N/A	Landing X Slope (%)	N/A	N/A	DWS Full Width?	N/A
N/A	Landing Curb? (Y/N)	N/A	N/A	DWS Offset (in)	N/A
N/A	Shared Landing?	N/A			
N/A	Gutter Ponding?	N/A	N/A	Gutter Slope (%)	N/A
N/A	Gutter Lip Ht (in)	N/A	N/A	Gutter X Slope (%)	N/A
N/A	Painted X Walk1?	No	N/A	Painted X Walk2?	No
	X Walk 1 Direction	To S		X Walk 2 Direction	To E
N/A	X Walk 1 Width (in)	N/A	N/A	X Walk 2 Width (in)	N/A
	X Walk 1 Slope (%)	0.2		X Walk 2 Slope (%)	0.7
	X Walk 1 X Slope (%)	1.7		X Walk 2 X Slope (%)	0.5
N/A	Ramp inside XWalk1?	N/A	N/A	Ramp inside XWalk2?	N/A
	Road Slope (%)	0.8	N/A	Clear Space?	N/A
	Road X Slope (%)	1.6	N/A	Clear Space to XWalk (in)	N/A
N/A	Any Obstructions?	N/A	N/A	Storm Grate/Utility Hazard?	N/A
	Obstruction Type			Storm Grate/Utility Type	
			N/A		N/A
			Yes	Surface Condition? (G/P)	Good
