# Access Compliance Report

## Public Rights-of-Way

### (Curb Ramps)

Intersection ID: 11313	Main Street: STAFFORD_DR	Cross Street: WILKINSON_BV	Location: SW
ADA ID: 9129E948E3F6	Ramp Type: MedianPerp	Initial Pass/Fail: Fail	Overall Compliance: No
		Severity Score: 12.5

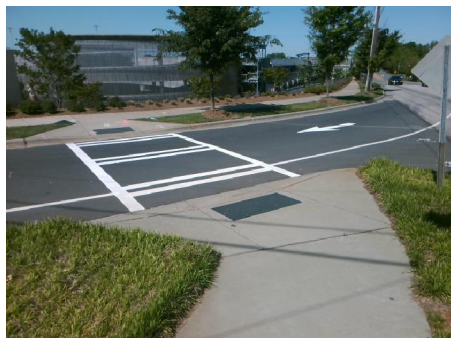
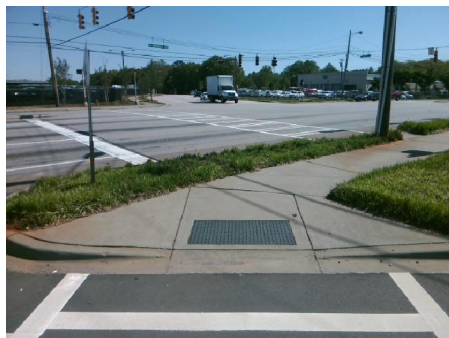
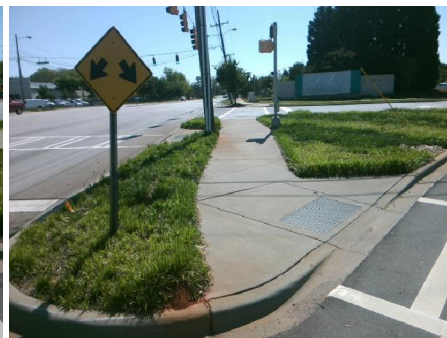
**Not Found, R304.2.2**

Compliance	Description	Data	Compliance	Description	Data
N/A	Ramp Length (in)	64.0	No	Ramp Slope (%)	9.7
Yes	Ramp Width (in)	63.0	Yes	Ramp XSlope (%)	0.1
N/A	Flare Type LT	N/A	N/A	Flare Type RT	N/A
N/A	Flare Slope LT (%)	N/A	N/A	Flare Slope RT (%)	N/A
N/A	Flare Traversable LT?	N/A	N/A	Flare Traversable RT?	N/A
N/A	Landing Length (in)	N/A	N/A	DWS Provided?	N/A
N/A	Landing Width (in)	N/A	N/A	DWS Contrast?	N/A
N/A	Landing Slope (%)	N/A	N/A	DWS Length (in)	N/A
N/A	Landing X Slope (%)	N/A	N/A	DWS Full Width?	N/A
N/A	Landing Curb? (Y/N)	N/A	N/A	DWS Offset (in)	N/A
N/A	Shared Landing?	N/A			
N/A	Gutter Ponding?	N/A	N/A	Gutter Slope (%)	N/A
N/A	Gutter Lip Ht (in)	N/A	N/A	Gutter X Slope (%)	N/A
N/A	Painted X Walk1?	Yes	N/A	Painted X Walk2?	N/A
	X Walk 1 Direction	To SW		X Walk 2 Direction	N/A
N/A	X Walk 1 Width (in)	113.0	N/A	X Walk 2 Width (in)	N/A
	X Walk 1 Slope (%)	1.8		X Walk 2 Slope (%)	N/A
	X Walk 1 X Slope (%)	1.0		X Walk 2 X Slope (%)	N/A

N/A	Ramp inside XWalk1?	Yes	N/A	Ramp inside XWalk2?	N/A
	Road Slope (%)	N/A	N/A	Clear Space?	N/A
	Road X Slope (%)	N/A	N/A	Clear Space to XWalk (in)	N/A
N/A	Any Obstructions?	N/A	N/A	Storm Grate/Utility Hazard?	N/A
	Obstruction Type			Storm Grate/Utility Type	
		N/A			N/A
			Yes	Surface Condition? (G/P)	Good

**Remove & Replace Entire Ramp.**

Total Cost: \$ **1650.00**
