Access Compliance Report Public Rights-of-Way (Curb Ramps)

Intersection ID: 52583Main Street:NEW_RENAISSANCE_WYCross Street:N/ALocation:NEADA ID: 912A52F7EC0BRamp Type:PerpInitial Pass/Fail:FailOverall Compliance:NoSeverity Score:25

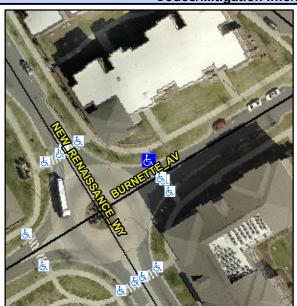
N/
PROW/ADA:
R304.2.2, R304.5.3

Field Measurements/Component Compliance					
Compl	iance Description	Data	Comp	liance Description	Data
N/A	Ramp Length (in)	84.0	No	Ramp Slope (%)	8.9
Yes	Ramp Width (in)	70.0	No	Ramp XSlope (%)	6.9
N/A	Flare Type LT	N/A	N/A	Flare Type RT	N/A
N/A	Flare Slope LT (%)	N/A	N/A	Flare Slope RT (%)	N/A
N/A	Flare Traversable LT?	N/A	N/A	Flare Traversable RT?	N/A
N/A	Landing Length (in)	N/A	N/A	DWS Provided?	N/A
N/A	Landing Width (in)	N/A	N/A	DWS Contrast?	N/A
N/A	Landing Slope (%)	N/A	N/A	DWS Length (in)	N/A
N/A	Landing X Slope (%)	N/A	N/A	DWS Full Width?	N/A
N/A	Landing Curb? (Y/N)	N/A	N/A	DWS Offset (in)	N/A
N/A	Shared Landing?	N/A			
N/A	Gutter Ponding?	N/A	N/A	Gutter Slope (%)	N/A
N/A	Gutter Lip Ht (in)	N/A	N/A	Gutter X Slope (%)	N/A
N/A	Painted X Walk1?	Yes	N/A	Painted X Walk2?	N/A
	X Walk 1 Direction	To S		X Walk 2 Direction	N/A
N/A	X Walk 1 Width (in)	123.0	N/A	X Walk 2 Width (in)	N/A
	X Walk 1 Slope (%)	4.4		X Walk 2 Slope (%)	N/A

X Walk 1 X Slope (%)	2.0		X Walk 2 X Slope (%)	N/A
N/A	Ramp inside XWalk1?	Yes	N/A	Ramp inside XWalk2?	N/A
	Road Slope (%)	N/A	N/A	Clear Space?	N/A
	Road X Slope (%)	N/A	N/A	Clear Space to XWalk (in)	N/A
N/A	Any Obstructions?	N/A	N/A	Storm Grate/Utility Hazard?	N/A
	Obstruction Type			Storm Grate/Utility Type	
		N/A			N/A
			Yes	Surface Condition? (G/P)	Good
100 Miles

Remove & Replace Entire Ramp.

Total Cost: \$ 1850.00
