Access Compliance Report Public Rights-of-Way (Curb Ramps)

Intersection ID: 12379Main Street: CRAIGWOOD_DRCross Street: KIMMERLY_GLEN_LNLocation:NEADA ID: 912C20D613F9Ramp Type: PerpInitial Pass/Fail: FailOverall Compliance: NoSeverity Score: 13.75

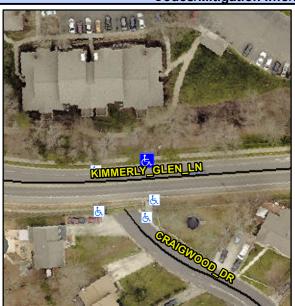
Compl	iance Description	Data	Comp	liance Description	Data
N/A	Ramp Length (in)	47.0	No	Ramp Slope (%)	11.0
Yes	Ramp Width (in)	48.0	No	Ramp XSlope (%)	2.6
N/A	Flare Type LT	N/A	N/A	Flare Type RT	N/A
N/A	Flare Slope LT (%)	N/A	N/A	Flare Slope RT (%)	N/A
N/A	Flare Traversable LT?	N/A	N/A	Flare Traversable RT?	N/A
N/A	Landing Length (in)	N/A	N/A	DWS Provided?	N/A
N/A	Landing Width (in)	N/A	N/A	DWS Contrast?	N/A
N/A	Landing Slope (%)	N/A	N/A	DWS Length (in)	N/A
N/A	Landing X Slope (%)	N/A	N/A	DWS Full Width?	N/A
N/A	Landing Curb? (Y/N)	N/A	N/A	DWS Offset (in)	N/A
N/A	Shared Landing?	N/A			
N/A	Gutter Ponding?	N/A	N/A	Gutter Slope (%)	N/A
N/A	Gutter Lip Ht (in)	N/A	N/A	Gutter X Slope (%)	N/A
N/A	Painted X Walk1?	No	N/A	Painted X Walk2?	N/A
	X Walk 1 Direction	To S		X Walk 2 Direction	N/A
N/A	X Walk 1 Width (in)	N/A	N/A	X Walk 2 Width (in)	N/A
	X Walk 1 Slope (%)	10.0		X Walk 2 Slope (%)	N/A
	X Walk 1 X Slope (%)	2.1		X Walk 2 X Slope (%)	N/A

N/A	Ramp inside XWalk1?	N/A	N/A	Ramp inside XWalk2?	N/A
	Road Slope (%)	N/A	N/A	Clear Space?	N/A
	Road X Slope (%)	N/A	N/A	Clear Space to XWalk (in)	N/A
N/A	Any Obstructions?	N/A	N/A	Storm Grate/Utility Hazard?	N/A
	Obstruction Type			Storm Grate/Utility Type	
		N/A			N/A
			Yes	Surface Condition? (G/P)	Good

1 CSSIBIC COIGUION	
Possible Solutions:	Com
Remove & Replace Entire Ramp.	N/A
	Yes
	N/A
	N/A
	N/A
	N/A
Surveyor Notes:	N/A
N/A	N/A
	N/A
	N/A
	N/A
PROW/ADA:	N/A
R304.2.2, R304.5.3	N/A
	N/A
	N/A
	N/A

1850.00
