Access Compliance Report

Public Rights-of-Way

(Curb Ramps)

Intersection ID: 3352	Main Street: DAVIS_RIDGE_DR	Cross Street: FALLS_RIDGE_LN	Location: SE
ADA ID: 91311EF46083	Ramp Type: PerpDiag	Initial Pass/Fail: Fail	Overall Compliance: No
Severity Score: 10			
Codes/Mitigation Info/Possible Solution		Field Measurements/Component Compliance

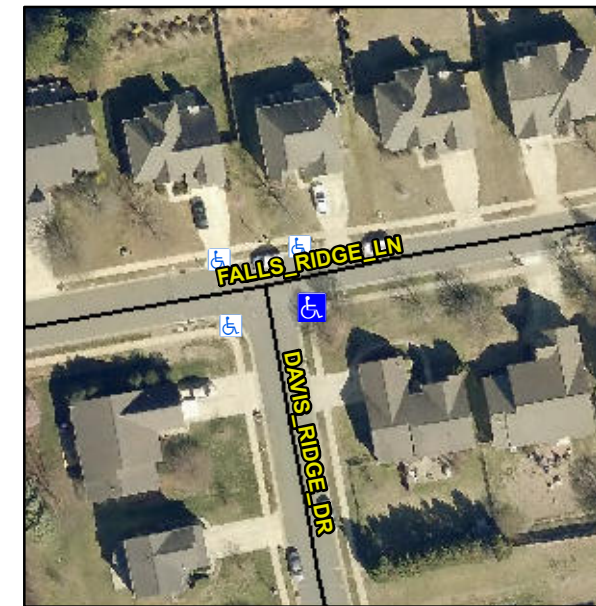
Compliance	Description	Data	Compliance	Description	Data
N/A	Ramp Length (in)	49.0	Yes	Ramp Slope (%)	6.7
No	Ramp Width (in)	47.0	No	Ramp XSlope (%)	3.3
N/A	Flare Type LT	N/A	N/A	Flare Type RT	N/A
N/A	Flare Slope LT (%)	N/A	N/A	Flare Slope RT (%)	N/A
N/A	Flare Traversable LT?	N/A	N/A	Flare Traversable RT?	N/A
N/A	Landing Length (in)	N/A	N/A	DWS Provided?	N/A
N/A	Landing Width (in)	N/A	N/A	DWS Contrast?	N/A
N/A	Landing Slope (%)	N/A	N/A	DWS Length (in)	N/A
N/A	Landing X Slope (%)	N/A	N/A	DWS Full Width?	N/A
N/A	Landing Curb? (Y/N)	N/A	N/A	DWS Offset (in)	N/A
N/A	Shared Landing?	N/A			
N/A	Gutter Ponding?	N/A	N/A	Gutter Slope (%)	N/A
N/A	Gutter Lip Ht (in)	N/A	N/A	Gutter X Slope (%)	N/A
N/A	Painted X Walk1?	No	N/A	Painted X Walk2?	No
	X Walk 1 Direction	To N		X Walk 2 Direction	To W
N/A	X Walk 1 Width (in)	N/A	N/A	X Walk 2 Width (in)	N/A
	X Walk 1 Slope (%)	4.9		X Walk 2 Slope (%)	6.3
	X Walk 1 X Slope (%)	3.4		X Walk 2 X Slope (%)	2.3

N/A	Ramp inside XWalk1?	N/A	N/A	Ramp inside XWalk2?	N/A
	Road Slope (%)	5.8	N/A	Clear Space?	N/A
	Road X Slope (%)	7.2	N/A	Clear Space to XWalk (in)	N/A
N/A	Any Obstructions?	N/A	N/A	Storm Grate/Utility Hazard?	N/A
	Obstruction Type			Storm Grate/Utility Type	
		N/A			N/A
		Yes		Surface Condition? (G/P)	Good

Possible Solutions:

Remove & Replace Curb Ramp With Two New Directional Ramps or Equivalent.

R304.5.1, R304.5.3
